# Nondestructive Ultrasonic Inspection of Composite Materials: A Comparative Advantage of Phased Array Ultrasonic

**Abstract:** Carbon- and glass fiber-reinforced polymer (CFRP and GFRP) composite materials have been used in many industries such as aerospace and automobile because of their outstanding strength-to-weight ratio and corrosion resistance. The quality of these materials is important for safe operation. Nondestructive testing (NDT) techniques are an effective way to inspect these composites. While ultrasonic NDT has previously been used for inspection of composites, conventional ultrasonic NDT, using single element transducers, has limitations such as high attenuation and low signal-to-noise ratio (SNR). Using phased array ultrasonic testing (PAUT) techniques, signals can be generated at desired distances and angles. These capabilities provide promising results for composites where the anisotropic structure makes signal evaluation challenging. Defect detection in composites based on bulk and guided waves are studied. The capability of the PAUT and its sensitivity to flaws were evaluated by comparing the signal characteristics to the conventional method. The results show

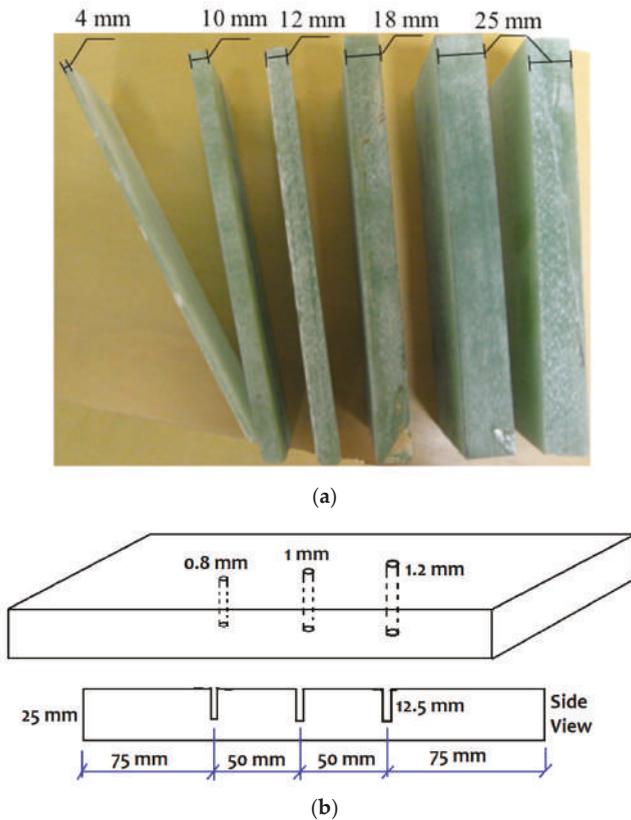
**Figure 1.** Samples used to evaluate capability and sensitivity of defect detection in single element ultrasonic (SEUT) versus phased array ultrasonic (PAUT) methods: (a) glass fiber reinforced polymer (GFRP) samples from a wind turbine blade and (b) schematic for the artificial hole locations in GFRP sample with 25mm thickness (Thk.). Sample size is 250 × 100 × 25 (L × W × Thk.) mm. Width of the sample is 100 mm and holes drilled in the middle of the width.

GFRP plates, extracted from a wind turbine blade, were used for the experiments as shown in Figure 1a. The GFRP samples have various thicknesses of 4, 10, 12, 18, and 25 mm. In order to study the sensitivity of flaw detection in both the PAUT and SEUT methods, various sizes of holes were drilled on one side of the sample (with the largest thickness being 25 mm), as shown schematically in Figure 1b.

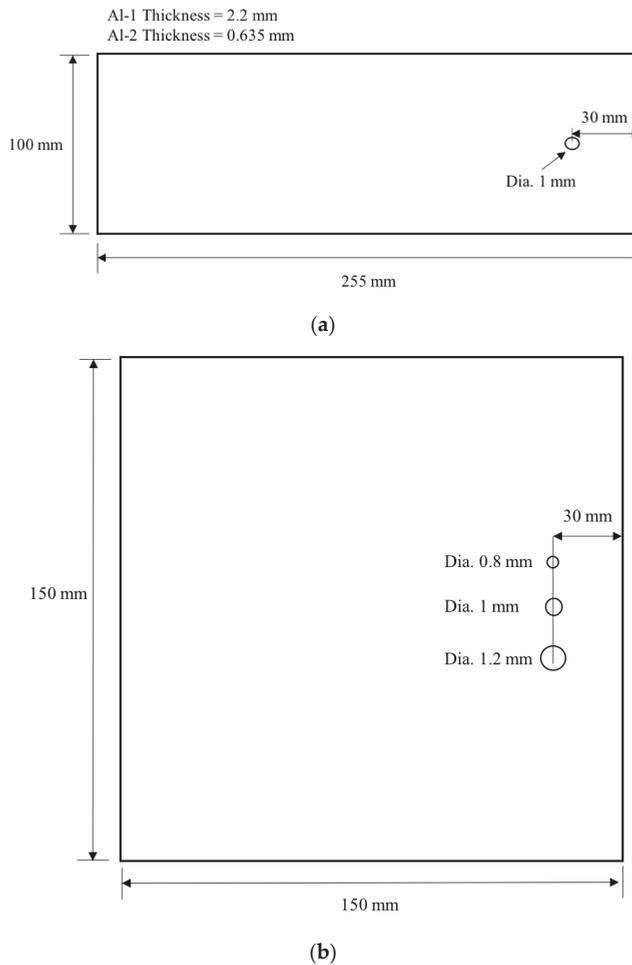
**Figure 2.** Schematic for the dimension and artificial holes locations in (a) Al-1 and Al-2 samples and (b) CFRP sample.

Table 5 shows the results of PAUT guided wave signal parameters for the CFRP sample. In Table 5, the arrival time of the reflection signal from the plate edge and the defect (hole) are presented (See Figure 2 for reference). The difference between the arrival times from the plate edge and from the defect (hole) was calculated. Considering the wave velocity, which was experimentally determined in a previous work [8], the distance between the plate edge and defect (hole) was determined experimentally. Comparing the distance between the plate and the defect (hole) which was determined experimentally with the actual location (as designed = 30 mm) shows that the location of the defect (hole) can be determined using the proposed technique within an acceptable range. When the size of the defect (hole) is larger, there is a better probability of detection, and the accuracy in determining the location of the defect (hole) is higher. In addition, when there is less interference between wave modes, such as in the case of larger distances, there is higher accuracy of detection. Better accuracy at larger distances occurs because, when the travelling distance for the guided waves is short, these wave modes are not stabilized and have many overlaps and low signal-to-noise ratio which cause higher inaccuracy. Figure 11 shows a typical signal for the experimental result listed in Table 5 for CFRP. Figure 12 shows the change in signal amplitude at different defect (hole) sizes for the experiments in Table 5 for CFRP. The amplitude of the signal from the plate edge is inversely proportional to the hole diameter. However, the amplitude of the signal from the hole is directly proportional to the hole diameter. As the hole diameter increases (i.e., larger defect), a larger part of the ultrasonic energy is reflected by the defect (hole), and consequently a smaller part will hit the edge.

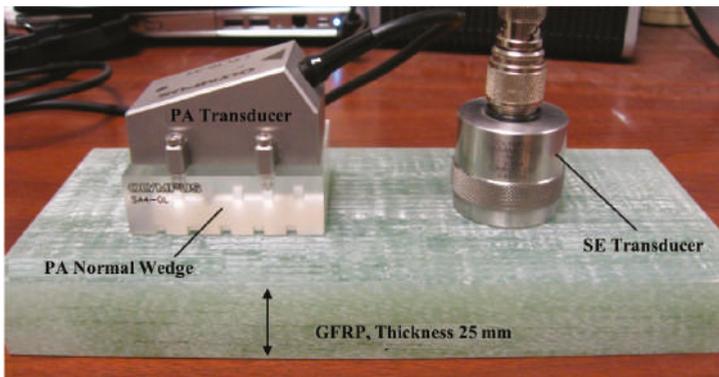
Figure 3. Experimental setup for capability and sensitivity evaluation: PAUT (left) and SEUT (right).

It is important to understand how far an ultrasonic signal can travel through the composite material while the back wall reflection is still detectable. This shows the capability of signal focusing and propagation for an ultrasonic setup. The SEUT experiments were performed using three different frequencies including 0.5, 1.0, and 1.5 MHz, where the attenuation of ultrasound signals at different frequencies was evaluated. In the PAUT experiments, a 1.5 MHz, 16-element transducer was used accompanying the related normal wedge. Both SEUT and PAUT transducer and setups are shown in Figure 3.

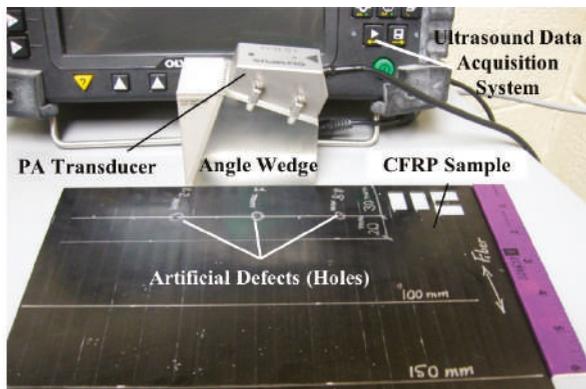
Figure 4. Experimental setup for flaw detection in CFRP sample using PAUT guided wave method.

Guided wave modes were generated on Al and CFRP plates by means of a commercially available phased array probe and wedges. The procedure of plate wave generation and parametric evaluation are described in detail in [8,18]. A 1.5 MHz phased array ultrasonic probe with 16 elements and related 60 degrees longitudinal wave wedge was used for guided wave generation and flaw detection. Figure 4 shows the setup used for inspecting the artificial defects (drilled holes) in CFRP sample. In CFRP sample, guided waves were generated in direction of the fibers.

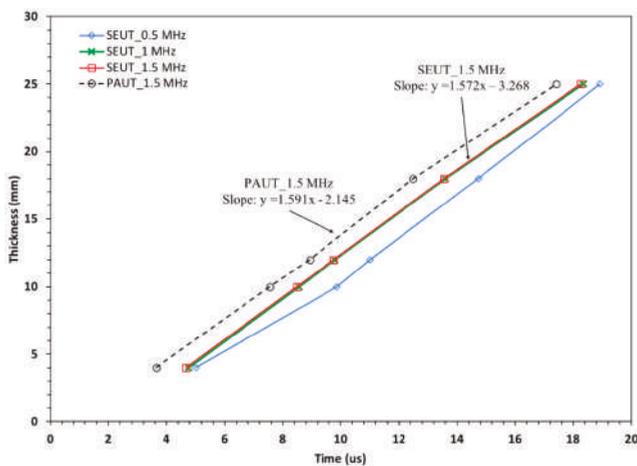
**Figure 5.** Back wall reflection experiment showing ultrasonic wave velocity evaluation measured by SEUT and PAUT methods.

Table 2 shows the signal characteristics in terms of signal-to-noise ratio (SNR) for SEUT and PAUT. Data in Table 2 is plotted in Figure 5 and shows the relationship between the thicknesses of the GFRP plates (i.e., wave traveling distance) and travelling time of ultrasound wave. It can be observed that the velocities in the GFRP plate can be calculated as twice the slope of the graph, which are equal to  $2 \times 1.57 = 3.15 \text{ mm}/\mu\text{s}$  for SEUT and  $2 \times 1.59 = 3.18 \text{ mm}/\mu\text{s}$  for PAUT. Figure 6 shows an example for typical signals for the back wall reflection in SEUT and PAUT methods in the 12-mm-thick composite plate. As can be seen from the results in Table 2 and considering the form of the ultrasound signal

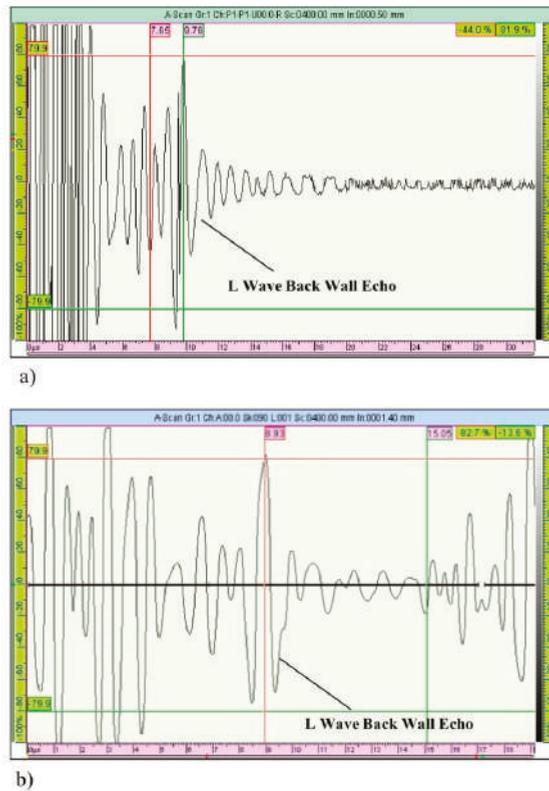
**Figure 6.** Back wall reflection signals for GFRP: (a) SEUT method and (b) PAUT method. (Freq. = 1.5 MHz, Thickness = 12 mm).

shown in Figure 6, the features of the signals are clearer and better detectable using PAUT with lower gain values. The wave velocity is important information in determining the depth and location of the defects according to the ultrasound wave’s traveling time.

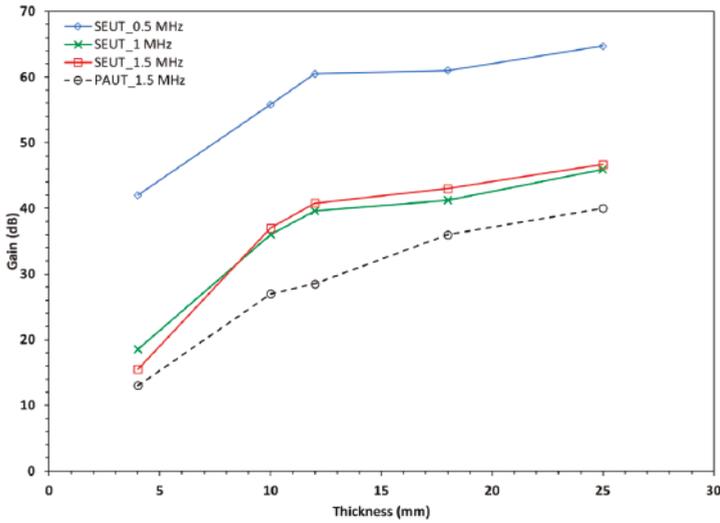
**Figure 7.** Gain (dB) value for back wall reflection detection in different sample thickness for attenuation characteristics evaluation using SEUT and PAUT techniques.

All the measured velocities are very close in value; however, the attenuation (i.e., gain values) is improved for PAUT when compared to SEUT at 1.5 MHz. On the other hand, the quantitative values in Table 2 show that SNR is, on average, two times larger for SEUT when comparing the peak of reflected signal to the background noise. However, it should be mentioned that the resolution of the peak and its location is much lower in SEUT which caused inaccuracy for detection purposes. Higher local value of SNR in SEUT can be attributed to the interference of the signals for each element in PAUT. Qualitatively, PAUT has more uniform and detectable signal with less jitter, specifically at larger thicknesses. Figure 7 shows the gain values (for different inspection frequencies) in order to reach detectable signal in different sample thicknesses. The plot shows that the SNR and signal's attenuation were improved in PAUT technique when compared to SEUT such that 7–20% less gain in value was required to have detectable signal in case of 1.5 MHz transducers.

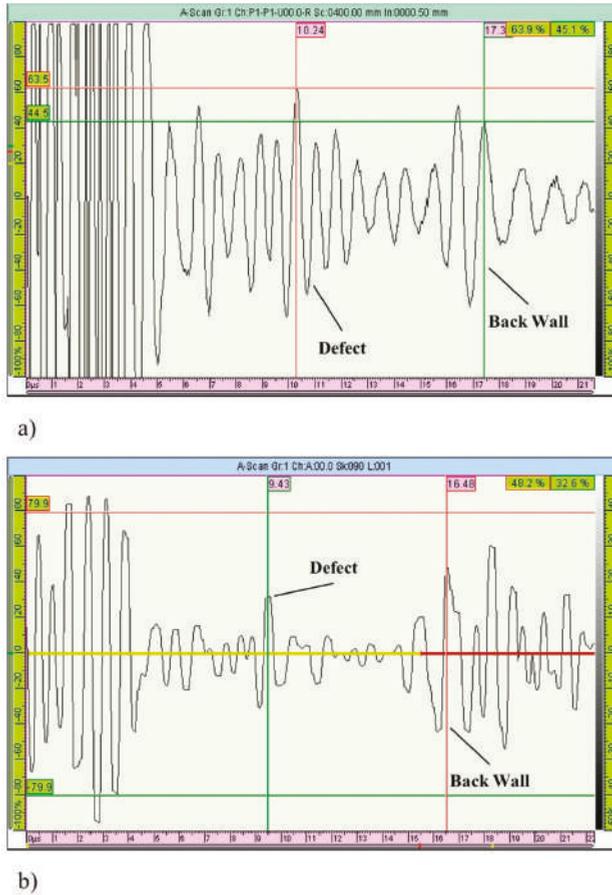
**Figure 8.** Response signal for CFRP: (a) SEUT method and (b) PAUT method. (Freq. = 1.5 MHz, Thickness = 25 mm, Hole Diameter = 0.8 mm, Hole Depth = 12mm).

Figure 8 shows the signals associated with the defect (artificially drilled holes) reflections by SEUT and PAUT methods. The depth of the hole can be determined based on the obtained velocity values, as in Equations (1) and (2). Both SEUT and PAUT techniques provided results that are very close to what was obtained by real time x-ray imaging (i.e., 11.175 mm) for validation. It was observed that both SEUT and PAUT techniques can detect a 0.8 mm diameter hole as the minimum size and sensitivity limit; however, PAUT method provides approximately 15% higher SNR for the defect signal. We believe that in PAUT, lower SNR and better signal characteristics, such as higher focusing energy, could assist in detecting smaller-sized defect sizes, and this needs further experimental evaluation.

In Figure 8, PAUT has a clearer and more easily detectable reflection from the defect (reflector), as well as a better detectable back wall reflection. However, when looking at SEUT signal, due to less smoothness in signal from one transducer element, it is more difficult to identify these reflection locations. In addition, as can be seen from the data in Table 2, the gain value is a very important factor. However in some cases the SNR in SEUT looks to be higher, but it was obtained with higher gain value. This happened when a small decrease in the gain value, less than the values in Table 2, did not provide a good detectable signal.

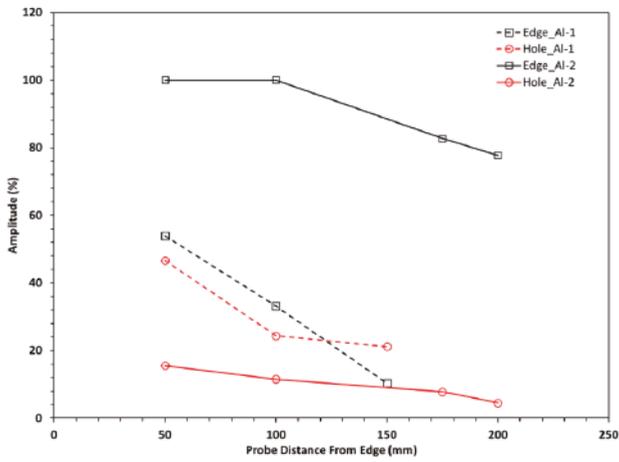
Figure 9. Change of signal amplitude over distance for Al-1 and Al-2 samples.

include the arrival time and the amplitude of the signal at the edge of the plate and the defect. Figure 9 shows the change of the signal’s amplitude over the distance of the PAUT transducer from the edge for Al-1 and Al-2. For Al-1 it was noticed that the hole’s signal has larger amplitude at a longer distance compared to Al-2. This is attributed to the interference of the stationary wedge reflection signal and the signal from the hole. Figure 10 shows typical signals for the experiments in Tables 3 and 4 for Al-1 and Al-2.

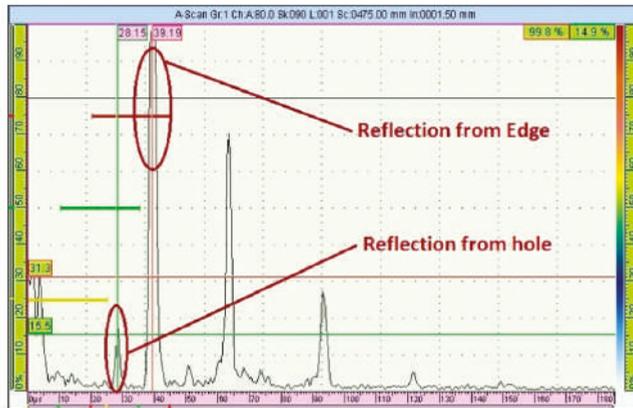
Figure 10. Typical PAUT guided wave signal of flaw detection for (a) Al-1 sample and (b) Al-2 sample.

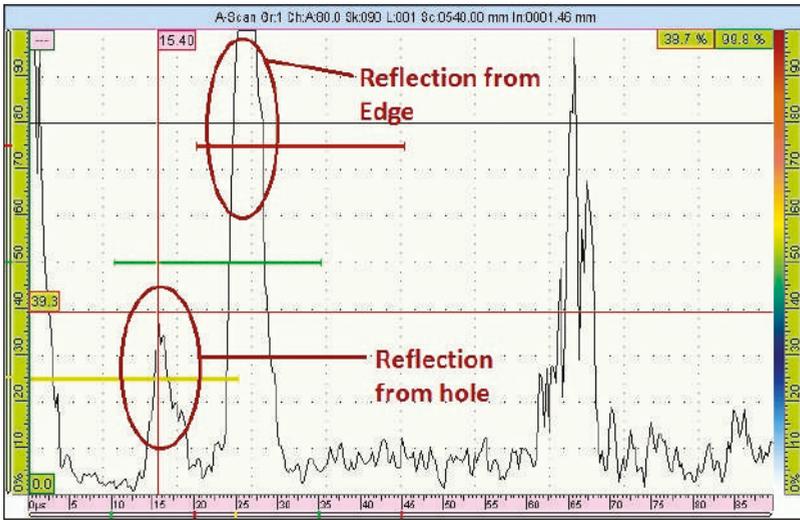
Figure 11. Typical PAUT guided wave signal of flaw detection for CFRP sample.

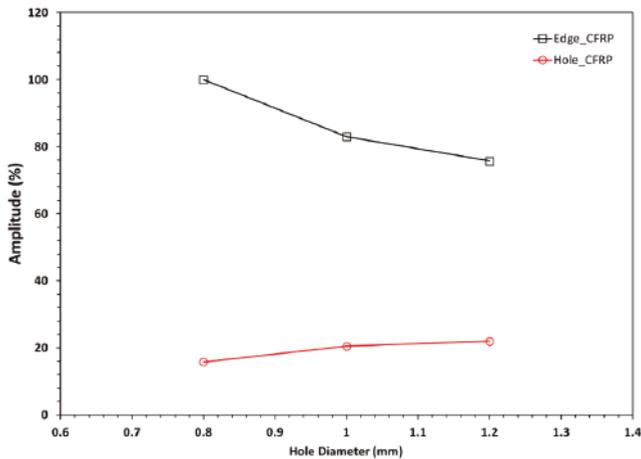
Figure 12. Change of signal amplitude over distance for CFRP samples.

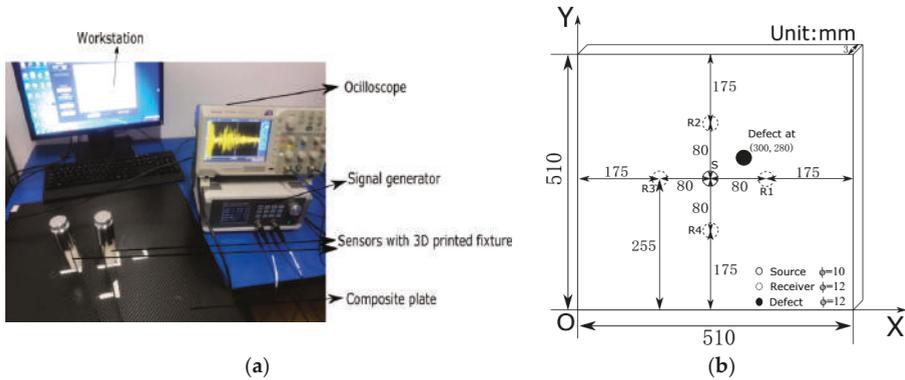
Figure 1. (a) Experimental set-up and (b) measurement scheme.

A  $[0^\circ/90^\circ]_{12}$  carbon fiber reinforced epoxy composite laminate made using a hot press process with unidirectional prepregs (Toray) is studied here; the experimental set-up is shown in Figure 1a. The plate is 510 mm  $\times$  510 mm  $\times$  3 mm in dimension. Since the thickness is small compared to the length and width dimensions, we will treat the plate as a two-dimensional model based on Equation (1). Due to the high attenuation of ultrasonic waves in the composite plate (4.3 dB/cm at 5 MHz [37]), the pitch-catch configuration is chosen and the gain is 17 dB. The high-pass filter is 1 MHz, while the low-pass filter is 10 MHz. The longitudinal transducer (A551S 5 MHz, Olympus, Inc., Tokyo, Japan) is excited using a pulsed source from a signal generator (Shantou Goworld Display Co., Ltd., Shantou, China). The waveform is recorded using a same type longitudinal transducer through an oscilloscope (TBS1202B, Tektronix, Inc., Beaverton, OR, USA) connected to a personal computer. The ultrasonic sensors are fixed to the plate by 3D printed fixtures with springs inside to apply constant forces on the sensors. A high viscosity couplant can provide good wave transmission and a traditional honey is applied. The defect is simulated using a circular piezoelectric medium attached to the composite plate surface [38]. Signals are amplified and averaged over 10 acquisitions for each source-receiver pair to minimize noises such as the rapid changes of capacitances between conductors due to flexing, twisting, or transient impacts on cables. Furthermore, since an important signal variation has been observed with a minor sensor movement, the defect is attached and detached repeatedly while keeping each source (S)-receiver ( $R_n$ ,  $n = 1-4$ ) pair fixed during signal recording (Figure 1b).

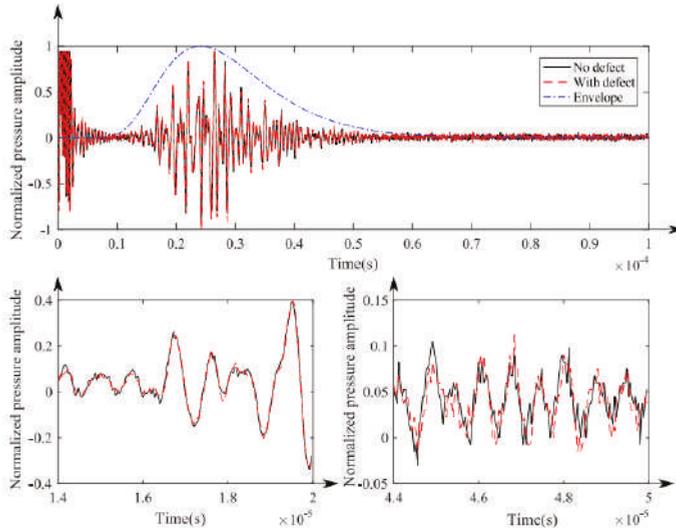
Figure 2. Representative waveforms from the S-R1 pair.

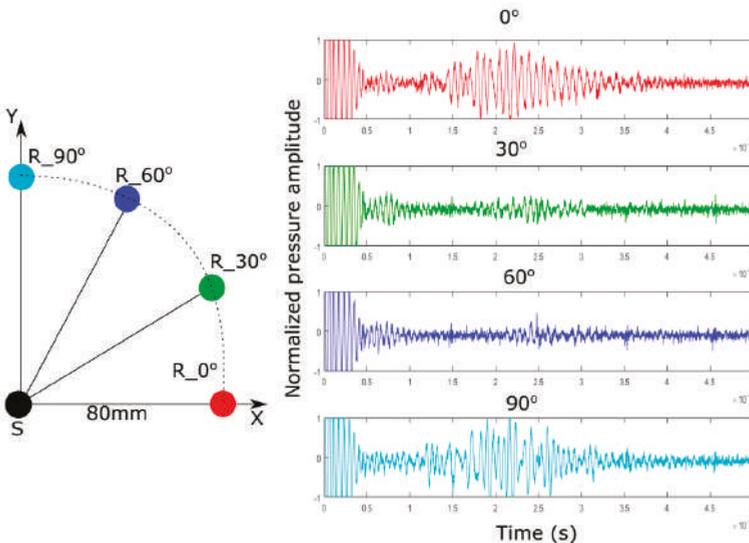
Figure 3. Waveforms from different directions at  $0^\circ$ ,  $30^\circ$ ,  $60^\circ$ , and  $90^\circ$ .

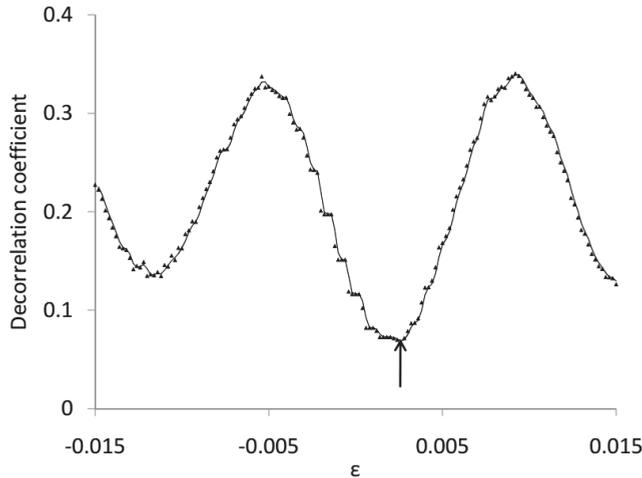
**Figure 4.** Decorrelation coefficient calculation example for the waveforms presented in Figure 2 when  $t_1 = 45 \mu\text{s}$  (decorrelation coefficient = 0.0679 when  $\varepsilon = 0.0026$ ).

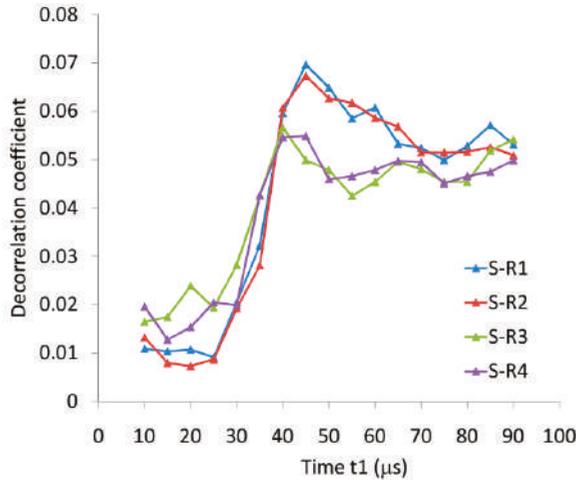
Figure 5. Decorrelation coefficients varied according to time.

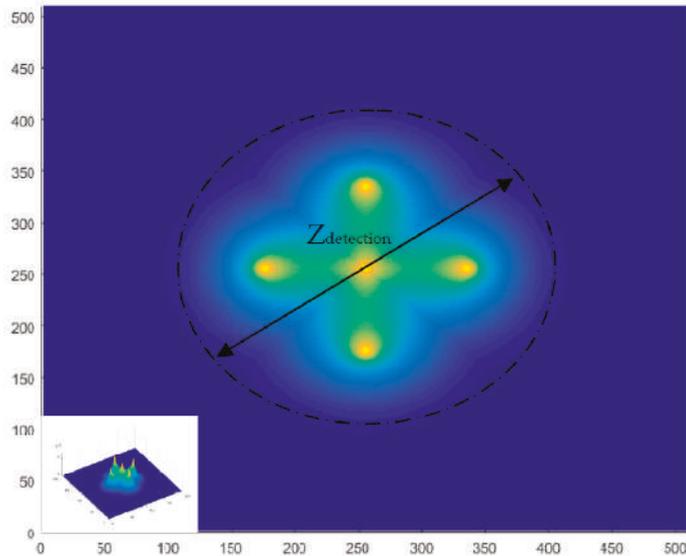
Figure 6. Sensitivity kernels and detection zone.

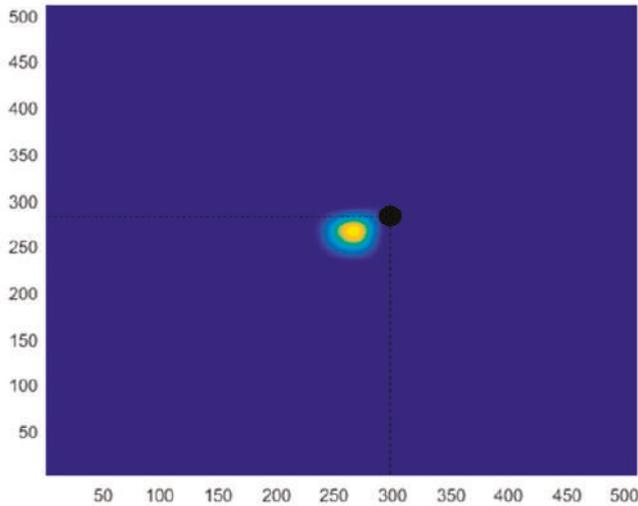
Figure 7. Localization image when  $t = 45 \mu s$ .

Once the decorrelation coefficients and kernel function have been calculated in the defined time domain, the localization is found to be in [270 mm, 265 mm] based on Equations (4)–(7), as shown in Figure 7. A further comparison is made among different time windows in Figure 8. The localization error varies from 13.5% to 6.7%. It decreases initially due to the increasing interaction between the diffuse wave and the defect. The direct reflection wave is estimated to arrive at the defect position at  $t_{reflection} = \frac{255+(255-80)}{8000} = 53 \mu s$ . Subsequently, the localization error increases because of the lowering sensitivity of the waveform to the defect shown in Figure 5, which may be caused by the reflection and attenuation. Although they suffer a lot from attenuation, which limits the inspection domain, a meaningful signal can still be extracted.

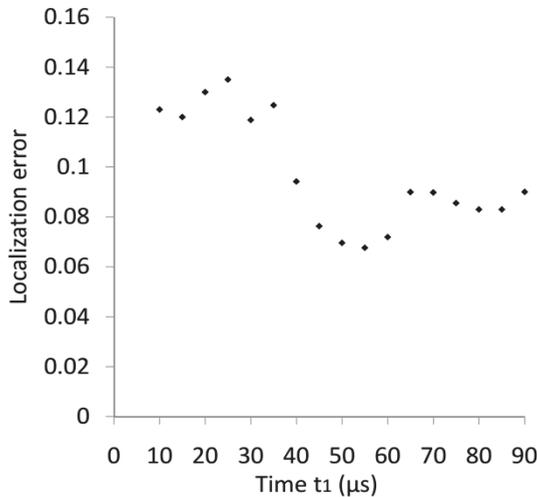
Figure 8. Localization error varied with time window.

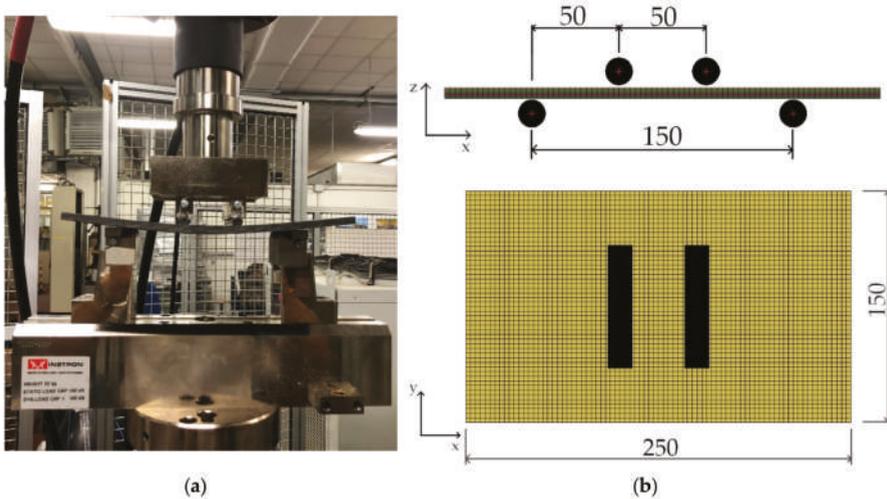
Figure 1. Four-point bending test: (a) experimental setup; (b) numerical model.

Four-point bending tests are performed on two different composite plates until complete failure occurs. The elastic field of the composite plates is thus identified. The tests are performed on a servohydraulic testing machine (Instron 8801). In agreement with the recommendations of ASTM standard D6272 for four-point bending test of reinforced plastics [22], the load span is one third of the support span. As shown in Figure 1, the loading noses are 50 mm distant. The support noses are consequently placed at a distance of 150 mm. Figure 1a shows the experimental setup. The resulting experimental curves of force with respect to displacement are exploited to tune a finite element model of the laminate subjected to four-point bending test, which is shown in Figure 1b.

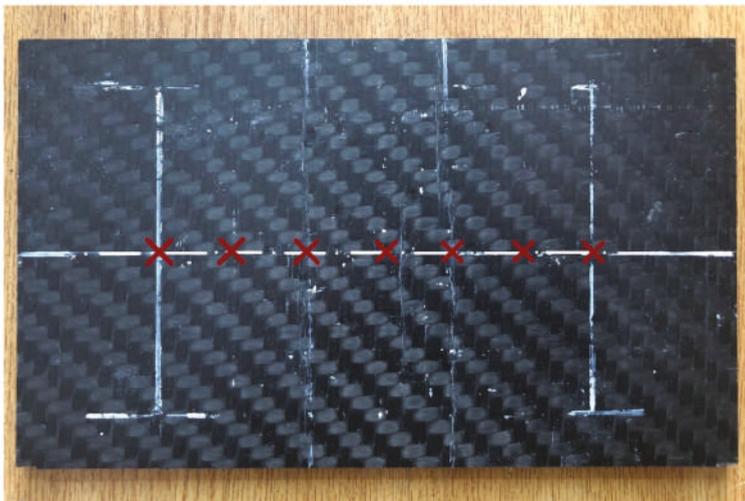
Figure 2. Location of impacts for  $DI_d$  analysis.

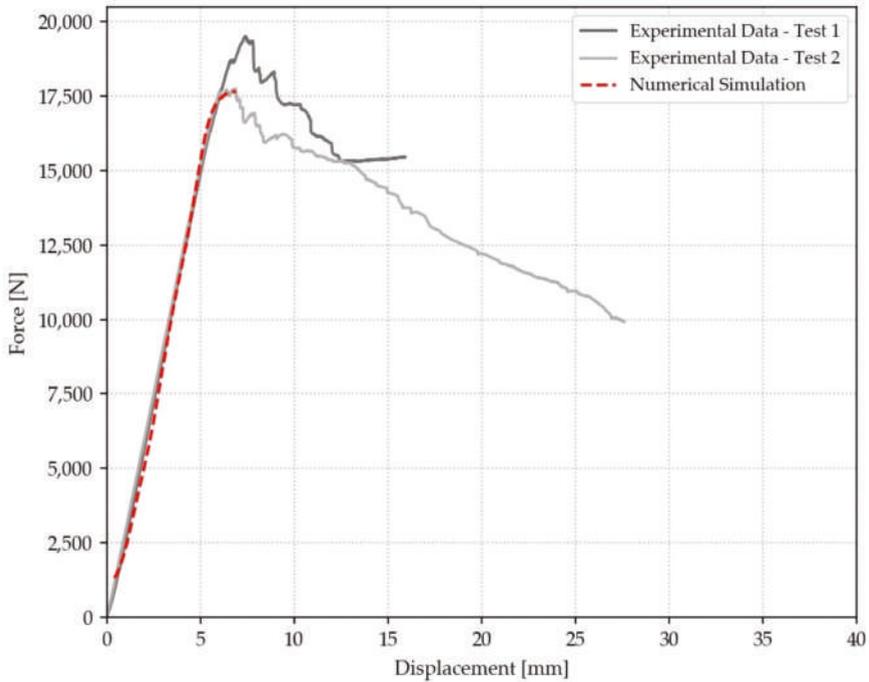
Figure 3. Experimental and numerical results of the four-point bending tests.

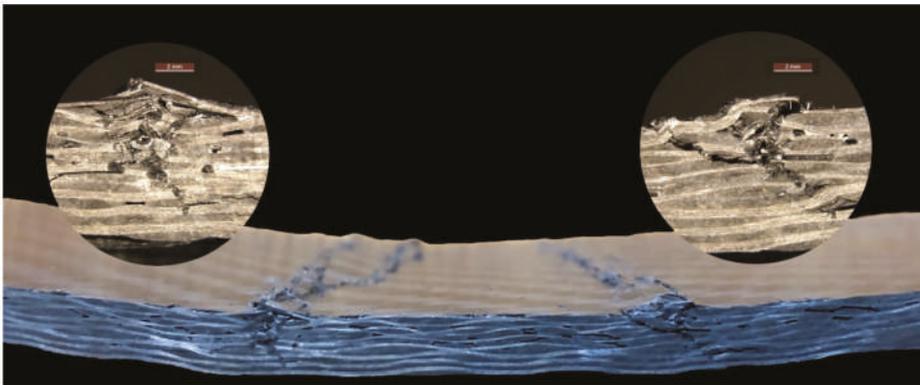
Figure 4. Magnification of intralaminar cracks: failure of the upper four layers.

Figure 4 shows a magnification of the cracks, obtained through an optical microscope. The complete failure can be appreciated for the upper four layers.

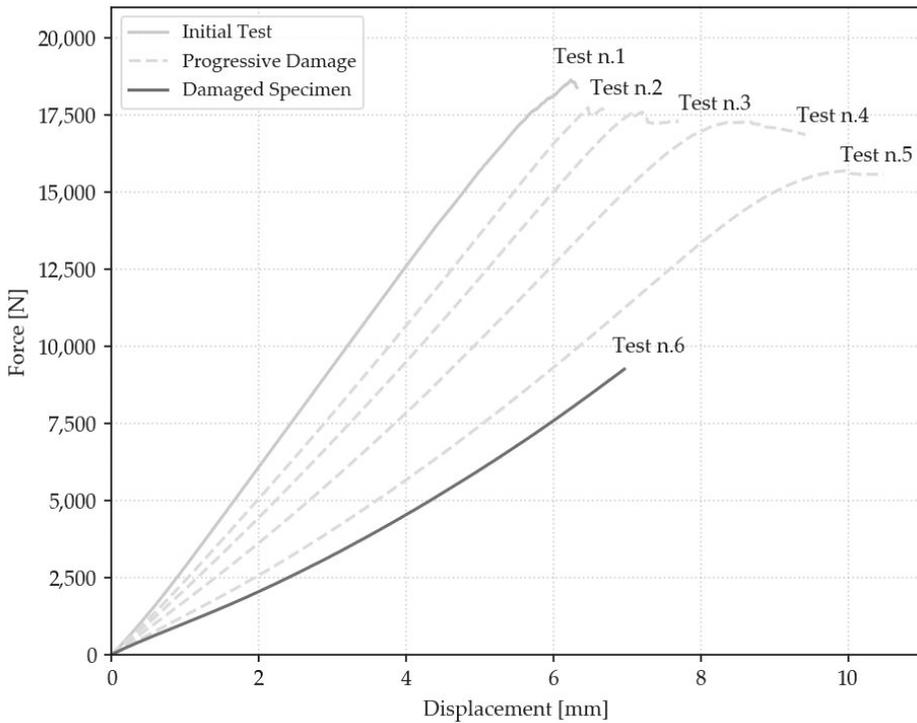
Figure 5. Progressive damaging of composite plate through four-point bending tests.

An undamaged composite is subjected to repeated four-point bending tests. Load is increased until incipient failure occurs and then decreased. Achieved failure is not complete, as the load-carrying capacity of the composite laminate is still significant. In total, five repetitions are performed, as shown in Figure 5, where the resulting force-displacement curves are numbered as Test n.1, Test n.2, Test n.3, Test n.4, and Test n.5. As the damage increases, the plate stiffness progressively decreases. Loading and unloading cycles are performed until the residual stiffness of the composite plate is about 40% of the original value. This is shown with the Test n.6 (damaged specimen curve), which is performed only in the elastic field. A significant damage level is thus induced through the five tests.

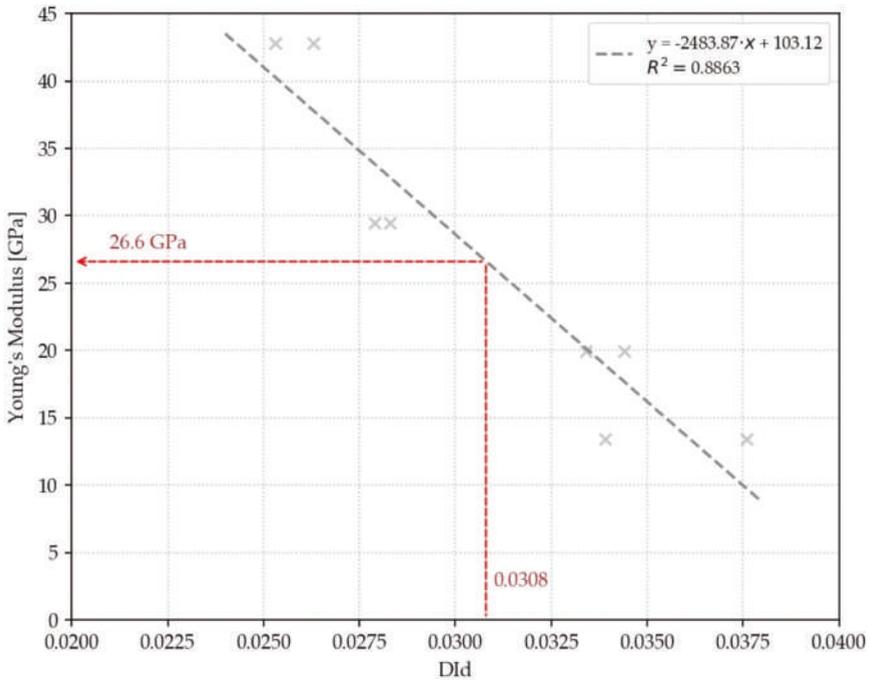
Figure 6. Residual Young's modulus evaluation with  $DI_d$ .

Figure 6 shows the resulting correlation between the residual elastic properties of the analyzed composite and the  $DI_d$  parameter. The dotted line is thus adopted to evaluate the residual elastic properties in the progressively damaged plate. Cross markers correspond to the preliminary characterization tests.

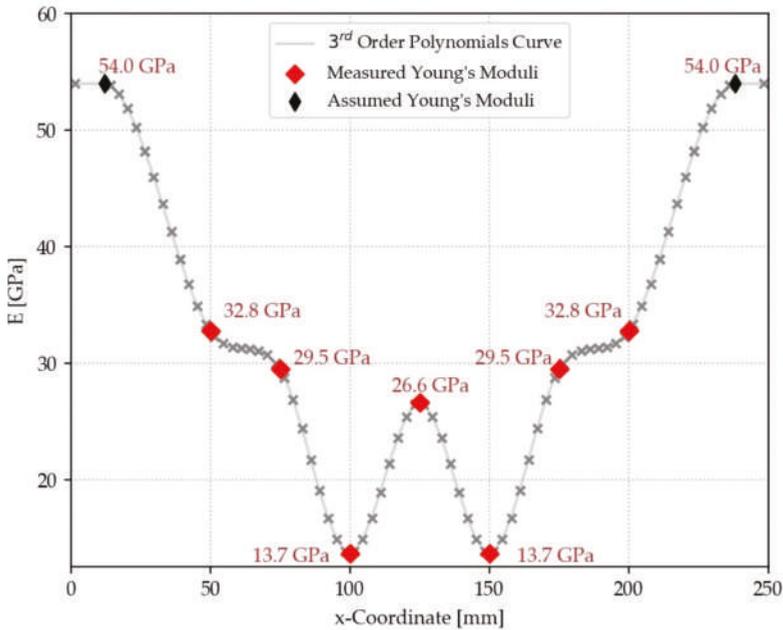
Figure 7. Variation of residual Young's modulus with respect to the x-coordinate.

Moving outwards from the external noses, the elastic modulus increases from 32.8 to 54 GPa and then is assumed constant. It should be noted that, as the bending moment is here null, the mechanical behavior of the numerical model will not be affected by the value of the elastic modulus estimated for this region.

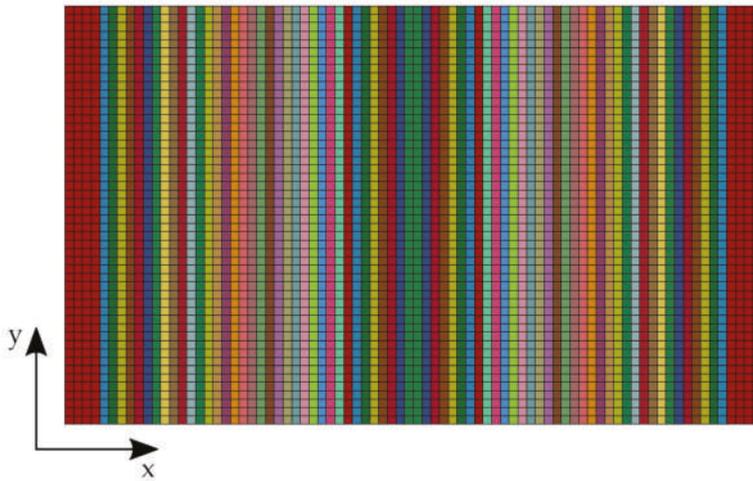
**Figure 8.** Top view of the finite element model of the composite laminate: longitudinal division of layers.

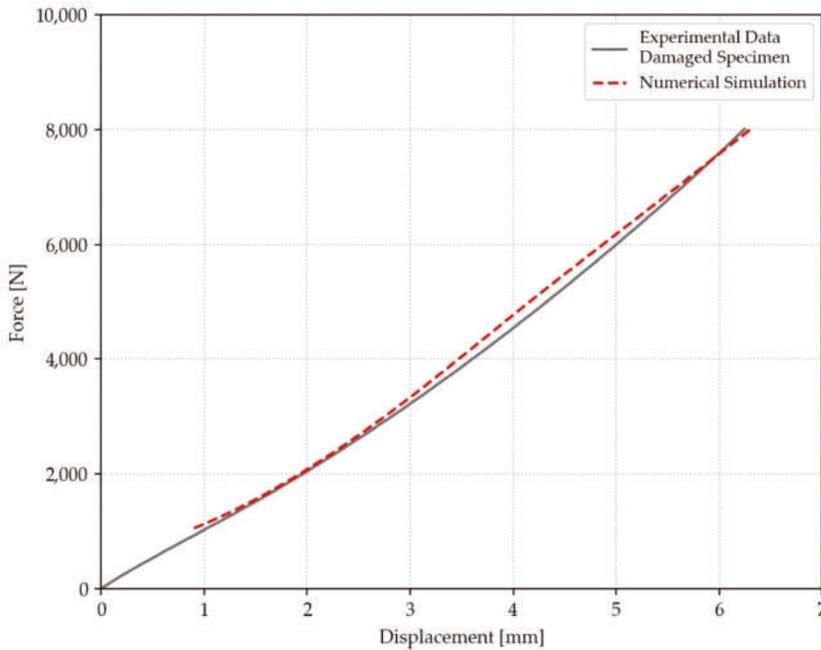
Figure 9. Comparison of experimental and numerical results of damaged specimen.

The limited discrepancy between experimental and numerical results highlights the accuracy of the  $DI_d$  technique in mapping the residual elastic properties of the damaged plate. Further, this result validates the proposed approach which accounts for the variable elastic modulus with a continuous polynomial curve in the finite element model.

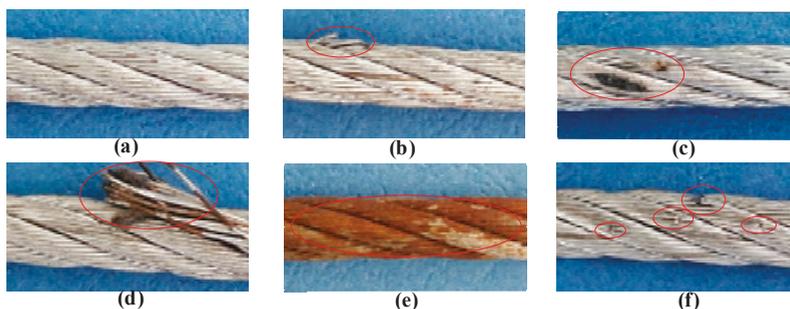
**Figure 1.** Sample pictures of wire rope damage. (a) Health; (b) wire breakage; (c) wear; (d) deformation (broken strand); (e) rust; and (f) fatigue (fatigue breaking).

Steel wire ropes will be damaged in various forms when used, which will reduce the strength of the WRs and pose a potential threat to the system safety. Various damage conditions and distribution have different effects on the strength reduction of WRs, and the whole WR is often scrapped due to a certain section of the WR. Therefore, the study of various damages of WRs will be beneficial to the correct evaluation of its state [8,9]. The damage types of WRs include wire breakage, wear, deformation, rust, and fatigue. Among them, fatigue has a variety of representations, such as internal and external cracks, internal and external wire breakages, and slack. The common types are shown in Figure 1.

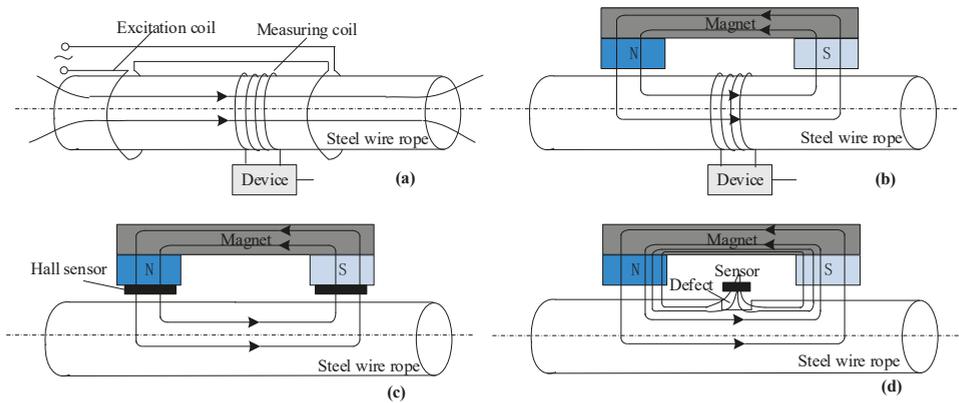
**Figure 2.** Electromagnetic non-destructive detection principle of steel wire rope. (a) Main magnetic flux detection method based on coil excitation; (b) main magnetic flux detection method based on permanent magnet excitation; (c) return magnetic flux detection method based on permanent magnet excitation; and (d) leakage magnetic flux detection method based on permanent magnet excitation.

The detection principle diagram is shown in Figure 2, the main principle is: after the WR is excited by coil or permanent magnet, the surface and internal damages will change the magnetic flux in the WR. Then the signal is detected by the induction coil or integrated sensor (e.g., Hall sensor and magnetoresistance sensor), and the type or degree of damages can be obtained to a certain extent through further processing and analysis of the signal [8–10]. Figure 2a is the main magnetic flux detection method based on coil excitation, which adopts the coaxial magnetization method, namely, taking the measured wire rope as the core, and the wire rope segment between the two coils is magnetized by the coil with current. Figure 2b is the main magnetic flux detection method based on permanent magnet excitation, in which the method of inter-pole magnetization is adopted, taking the wire rope as a component of the magnetic circuit, and the induction coil is used to detect the change of magnetic flux inside the wire rope caused by damage. Figure 2c is a method of return magnetic flux detection based on permanent magnet excitation, whose excitation mode is the same as Figure 2b, but the Hall sensor is used to detect the flux density in the magnetic circuit formed by excitation device, air gap and wire rope. Figure 2d is leakage magnetic flux detection method based on permanent magnet excitation, whose excitation mode is the same as Figure 2b,c, however, the difference is that the sensor is used to collect the leakage magnetic field information caused by the damage.

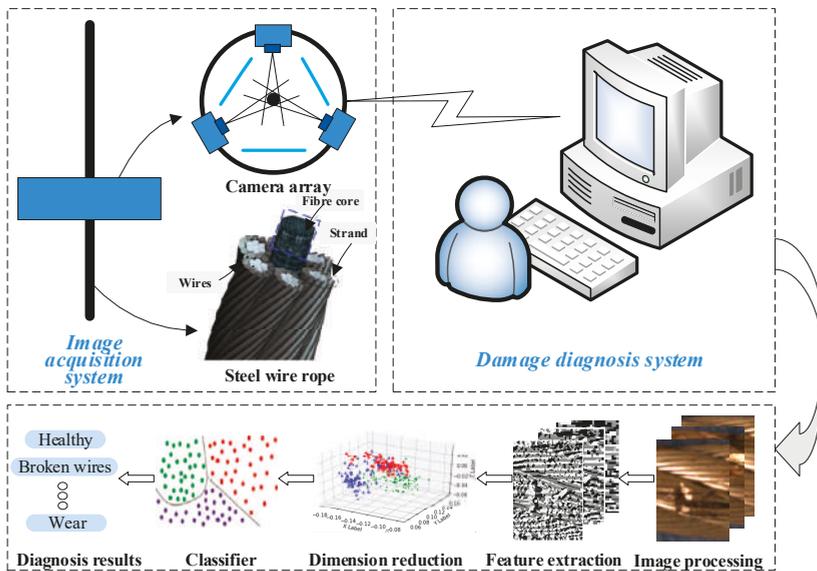
Figure 3. Optical detection principle for steel wire rope.

The principle of optical detection method is shown in Figure 3, which generally includes two parts: image acquisition and damage diagnosis. The image acquisition generally uses high-speed camera to collect the surface image of WRs, and the damage diagnosis includes image preprocessing and pattern recognition. WR damage detection based on pattern recognition is a potential research direction. Specifically, the hardware and software of the image acquisition system are configured according to the actual situation; the collected images are first processed by pretreatment method like cutting or filtering. Then, feature extraction methods (such as local binary pattern and gray level co-occurrence matrix) are used to extract features, and next dimensionality reduction is carried out on the established feature datasets. Finally, machine learning classifiers (such as support vector machines, artificial neural networks, etc.) are used for training and testing to obtain robust classifiers for state recognition of unknown images [42].

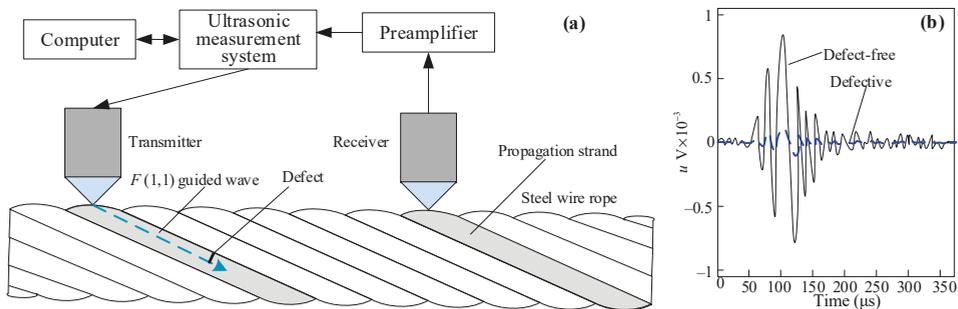
**Figure 4.** Non-destructive testing principle of steel wire rope by ultrasonic guided wave method [52]. (a) Detection system schematic diagram; (b) sketch map for waveforms of defect-free and defective signal.

Ultrasonic guided waves method (UGW) is one of the promising methods for investigation of non-homogeneities for the internal structure of WRs [51]. The measurement schematic diagram is illustrated in Figure 4, which is consisted of the computer, the ultrasonic measurement system, the preamplifier, the transmitter, and the receiver, detailed principles are available for reference [52]. The wave is launched on WRs and propagates along the strand of WRs. Acoustic reflection occurs when the sound wave passes through the damage. After collecting and analyzing the echo at the receiving end, the damage inside and outside the WR can be obtained [53].

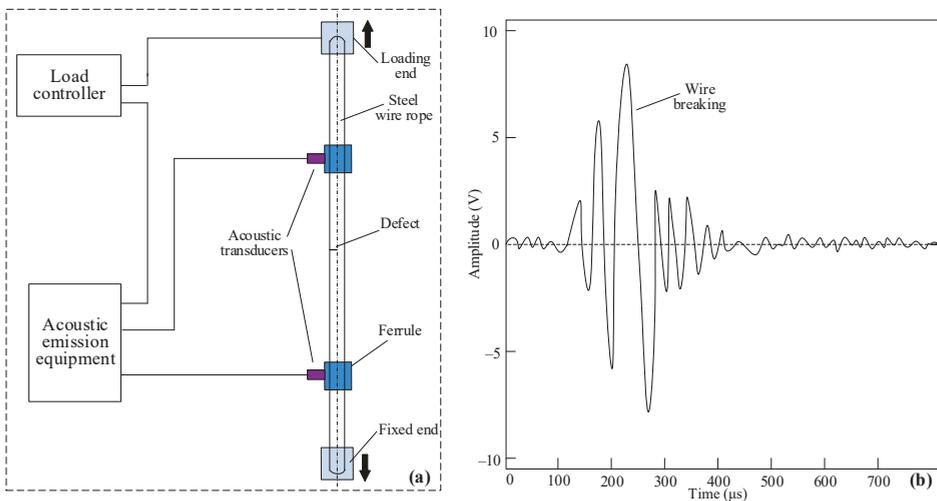
**Figure 5.** Acoustic emission detection for steel wire rope [61]. (a) Detection system schematic diagram; (b) sketch map for waveform of defects and wire breaking signal.

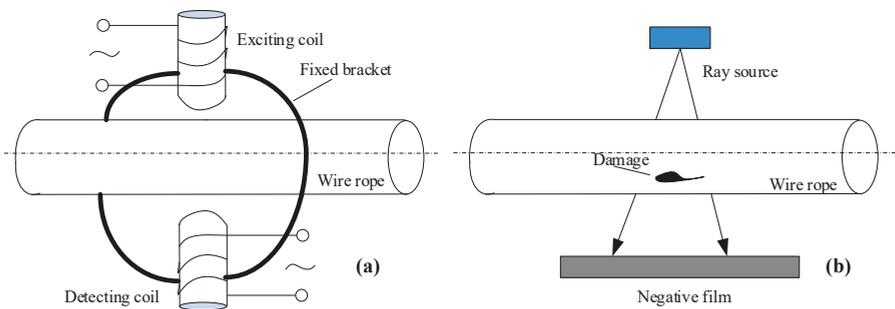
**Figure 6.** The other detection method principles. (a) Eddy current method [74]; (b) ray method [75].

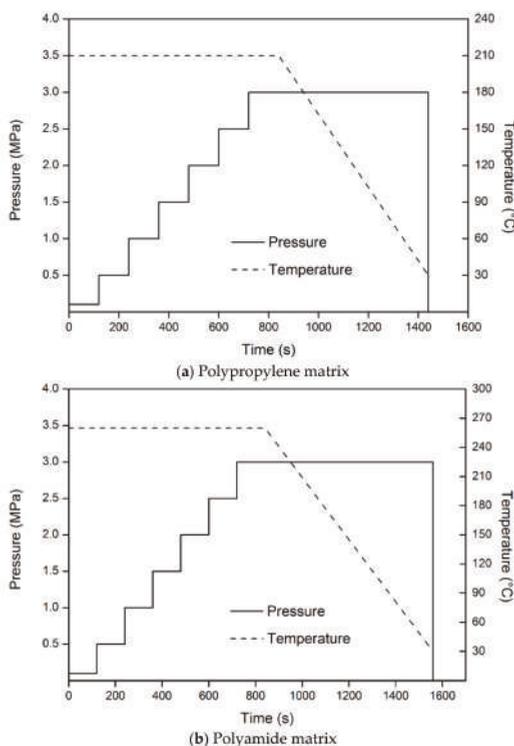
**Figure 1.** Molding compression pressure and temperature against time for polypropylene (PP) based (a) and polyamide (PA6B) based (b) matrices.

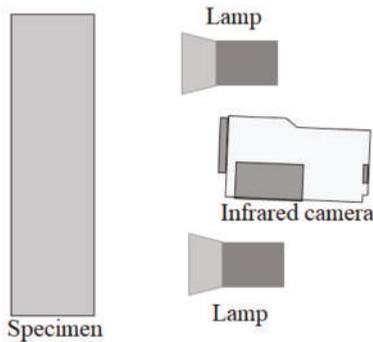
Figure 2. Scheme of the lock-in thermography setup.

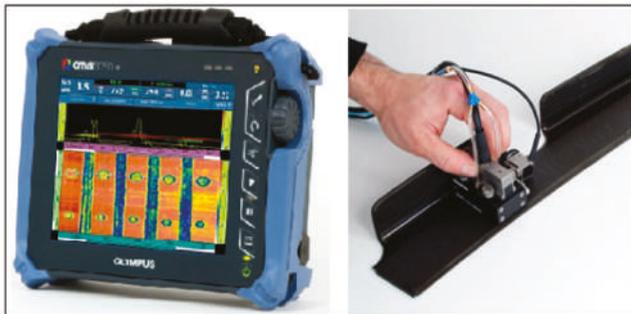
Figure 3. Some details of the ultrasonic (UT) testing setup.

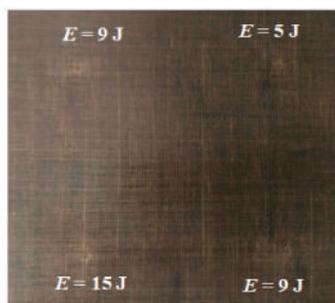
**Figure 4.** Photo of the polypropylene added with 2% maleic anhydride (PA6B) specimen with indicated energy and location of the impacts.

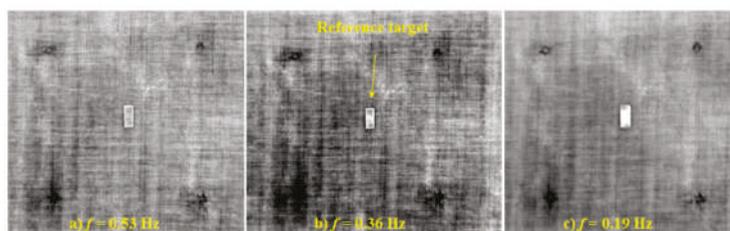
**Figure 5.** Phase images taken on the impacted side of the PA6B specimen at three heating frequencies; (a)  $f = 0.53$  Hz; (b)  $f = 0.36$  Hz; (c)  $f = 0.19$  Hz (see Figure 2 for impact energies location).

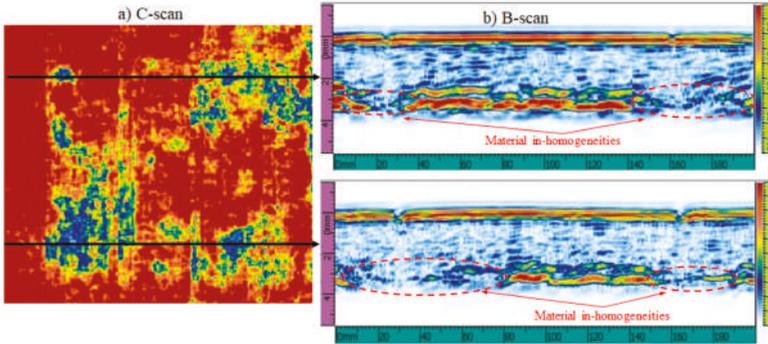
**Figure 6.** C-scan (a) and B-scan (b) images taken on the impacted side of the PA6B specimen (see Figure 4 for impact energies location).

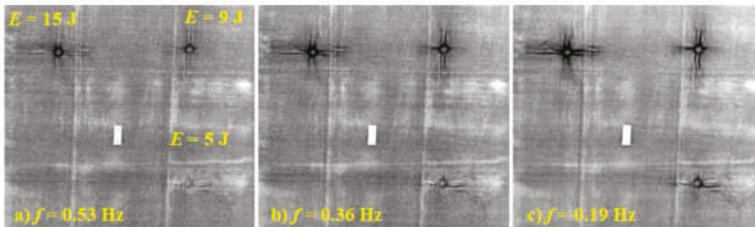
**Figure 7.** Phase images taken on the impacted side of the pure polypropylene (PPB) specimen at three heating frequencies; (a)  $f = 0.53$  Hz; (b)  $f = 0.36$  Hz; (c)  $f = 0.19$  Hz.

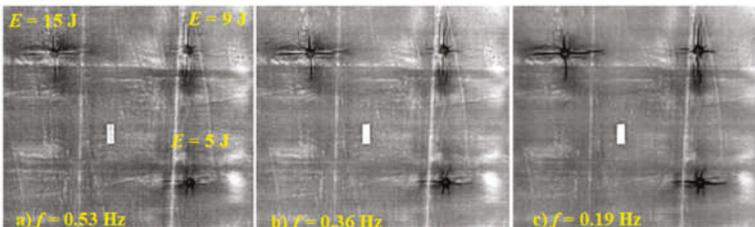
**Figure 8.** Phase images taken on the impacted side of the PC2B specimen at three heating frequencies; (a)  $f = 0.53$  Hz; (b)  $f = 0.36$  Hz; (c)  $f = 0.19$  Hz.

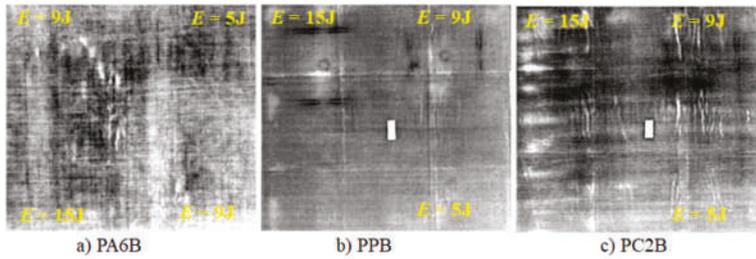
**Figure 9.** Phase images taken at  $f = 0.19$  Hz on the rear side of the three specimens; (a) PA6B; (b) PPB; (c) PC2B.

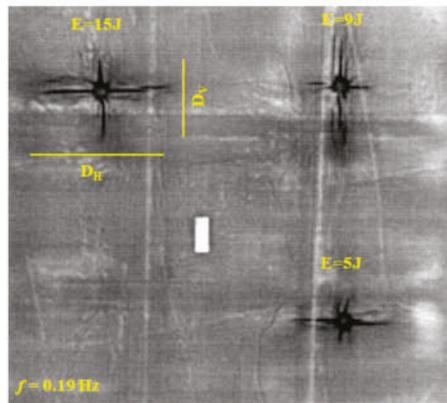
**Figure 10.** Indication of  $D_H$  and  $D_V$  over a phase image.

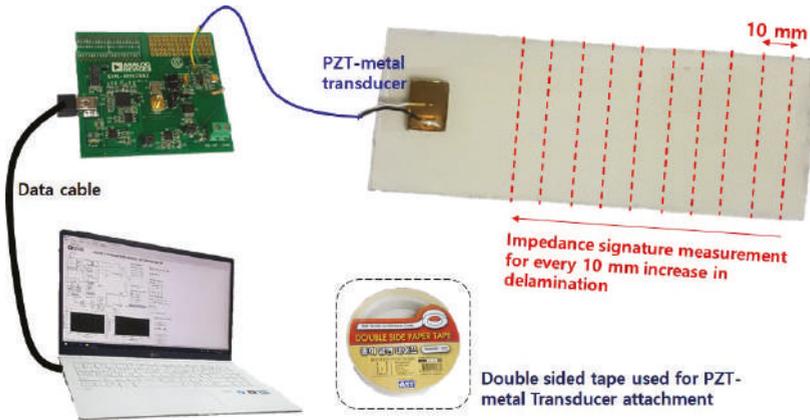
Figure 1. Experimental setup for the piezoelectric (PZT)-metal transducer experiment.
