# Nondestructive Ultrasonic Inspection of Composite Materials: A Comparative Advantage of Phased Array Ultrasonic

**Abstract:** Carbon- and glass fiber-reinforced polymer (CFRP and GFRP) composite materials have been used in many industries such as aerospace and automobile because of their outstanding strength-to-weight ratio and corrosion resistance. The quality of these materials is important for safe operation. Nondestructive testing (NDT) techniques are an effective way to inspect these composites. While ultrasonic NDT has previously been used for inspection of composites, conventional ultrasonic NDT, using single element transducers, has limitations such as high attenuation and low signal-to-noise ratio (SNR). Using phased array ultrasonic testing (PAUT) techniques, signals can be generated at desired distances and angles. These capabilities provide promising results for composites where the anisotropic structure makes signal evaluation challenging. Defect detection in composites based on bulk and guided waves are studied. The capability of the PAUT and its sensitivity to flaws were evaluated by comparing the signal characteristics to the conventional method. The results show

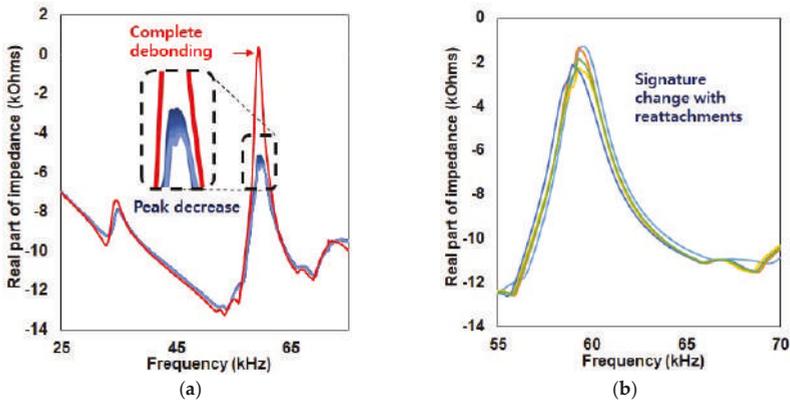
Figure 2. Impedance signature results for: (a) Debonding experiment; (b) re-attachable performance of the PZT-metal transducer.

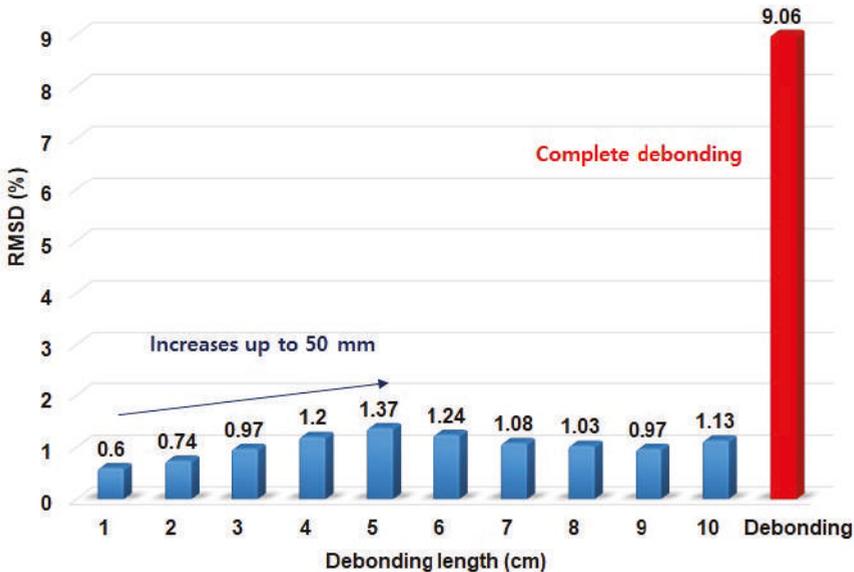
Figure 3. Root-mean-square deviation (RMSD) values for the debonding experiment and total removal of the bottom plate for Test 1.

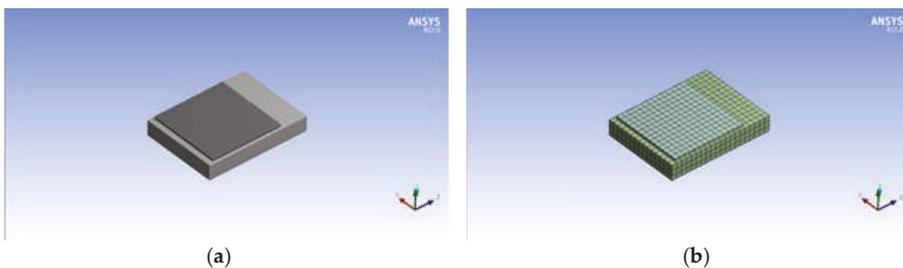
**Figure 4.** ANSYS FEM model: (a) PZT–metal; (b) mesh with 1096 elements.

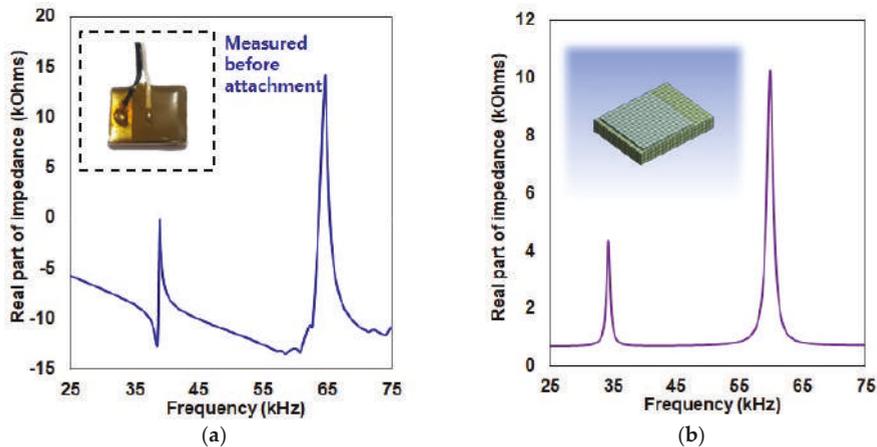
Figure 5. Impedance signature of the PZT–metal transducer before structure attachment: (a) By experiment; (b) by simulation.

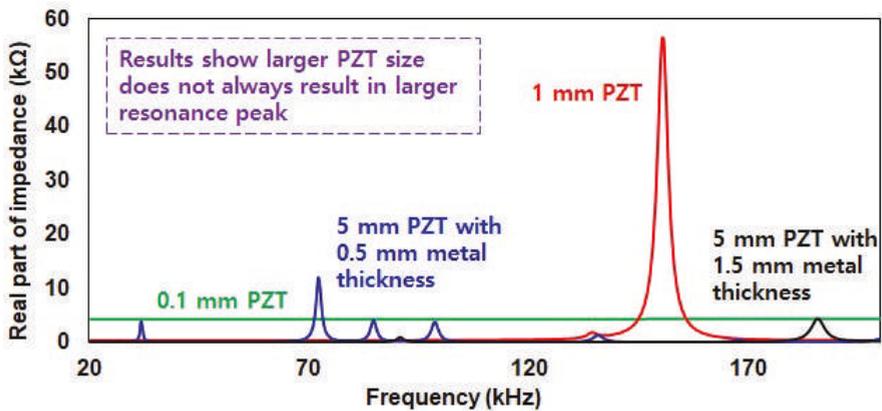
Figure 7. Simulation results for the impedance signatures of the four FEM models.

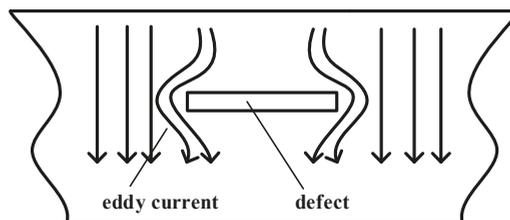
Figure 1. Eddy current at the edge of the defect.

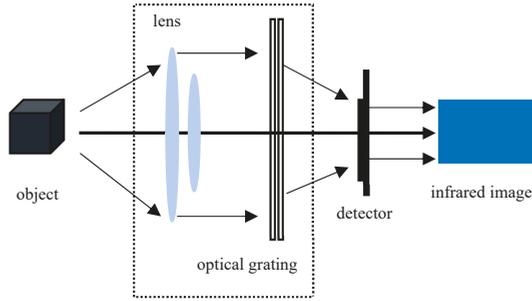
Figure 2. Operating principle of infrared thermal imager.

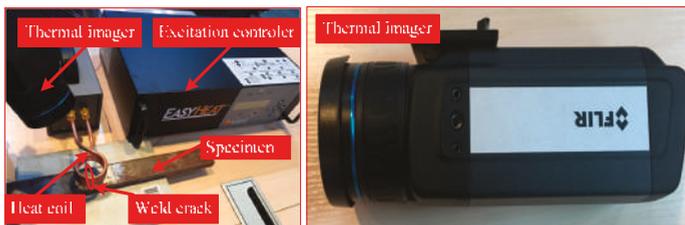
Figure 5. Experimental setup.

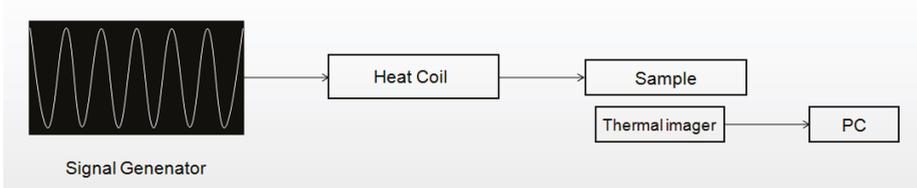
Figure 6. Signal flow chart.

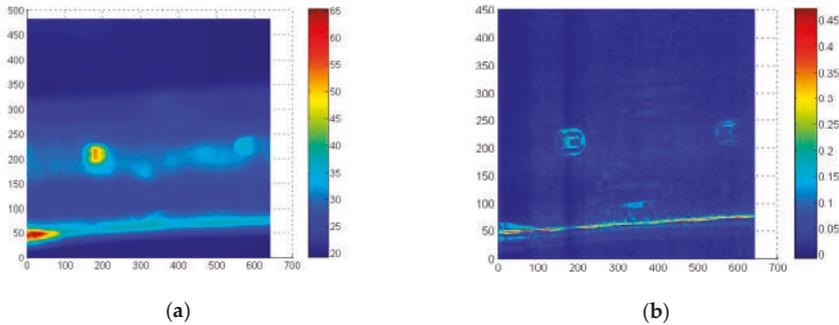
Figure 9. Comparison of initial and processed images: (a) Initial infrared image; (b) Infrared image after processing.
