# Non-destructive Testing of Materials in Civil Engineering

Printed Edition of the Special Issue Published in *Materials*

**Krzysztof Schabowicz**

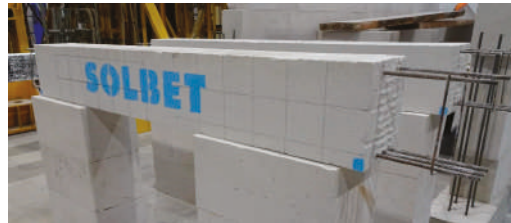
Figure 5. Tested elements with the reinforcement broken down at its ends.

Two beams were selected for tests. To ensure the precise location of the reinforcement, both ends of tested beams were broken down and the reinforcement was measured, as in Figure 5. Tiny openings (diameter of 2 mm) were made in 11 places on lateral surfaces and at eight bottom points (between stirrups) to measure the real reinforcement cover— $c_{obs}$  with the accuracy of  $\Delta c_{obs} = \pm 0,1$  mm. As the location of both beams was the same, tests were only conducted on one of them.

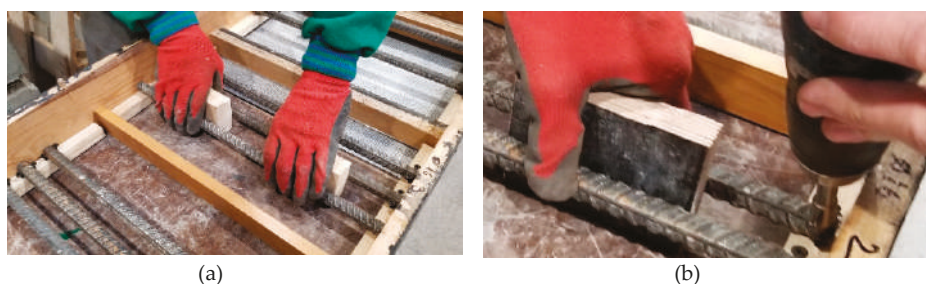
**Figure 7.** Stabilization of reinforcement in formwork: (a) distance resulting from wooden spacers, (b) rebar fastening to wooden washers with screws.

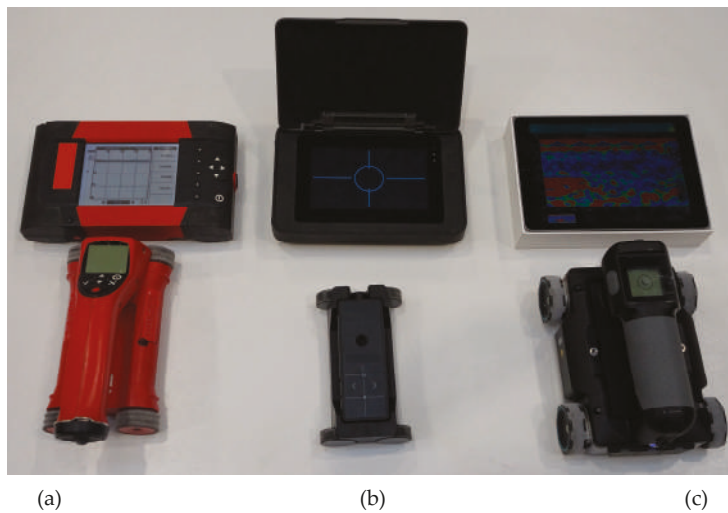
**Figure 9.** Devices used in tests, (a) electromagnetic device (1), (b) electromagnetic device (2), and (c) radar device (3).

The tests were conducted using two electromagnetic scanners: PS 200 (manufacturer Hilti Corp., Schaan, Lichtenstein), Profometer 630 AI (manufacturer Proceq AG, Schwerzenbach, Switzerland) and one GPR device –GPR Live (manufacturer Proceq AG, Schwerzenbach, Switzerland). Figure 9 shows the testing apparatus. A scanning transducer of the electromagnetic device 1 was equipped with one circumferential transmitting coil and seven pairs of receiving coils. The receiving coils induce current with microammeters, and the received signal is then processed and analysed. The electromagnetic device no. 2 is similar in principle. The radar equipment 3 was equipped with antennas to perform tests, while using a signal with a variable frequency within a range of 0.2–4.0 GHz. Frequency was changed progressively in an automatic way during tests, and the max. acquisition time was 20 ns.

The measuring accuracy of each device was the same,  $\Delta c_{\text{obs}} = \pm 1.0 \text{ mm}$  (according to information provided by device manufacturers).

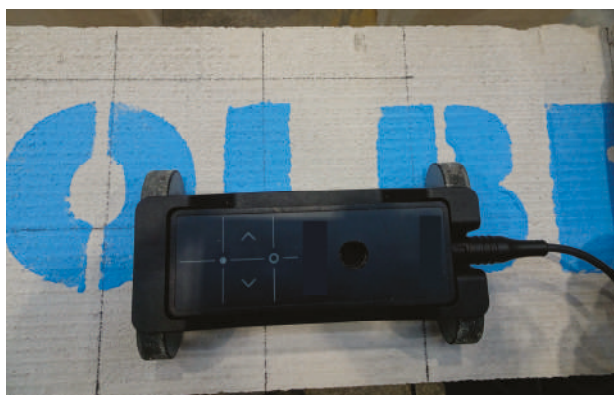
**Figure 10.** Transducer on the surface of the tested element.

The tests were performed with each device by scanning the same points on the lateral and bottom surface of beams. Stirrup rebars were detected on the lateral surface, whereas the main reinforcement was tested from the bottom. During tests, line and area scans were conducted. Thus, the test consisted in moving the transducer along lines or areas that were routed on the surface of the tested element (Figure 10). Figure 11a illustrates scanned areas for stirrup testing and Figure 11b presents scanned areas for testing the main reinforcement. Figure 11c shows the location of a line scan and the point of measuring stirrups, whereas Figure 11d shows the location of a line scan for the main reinforcement.

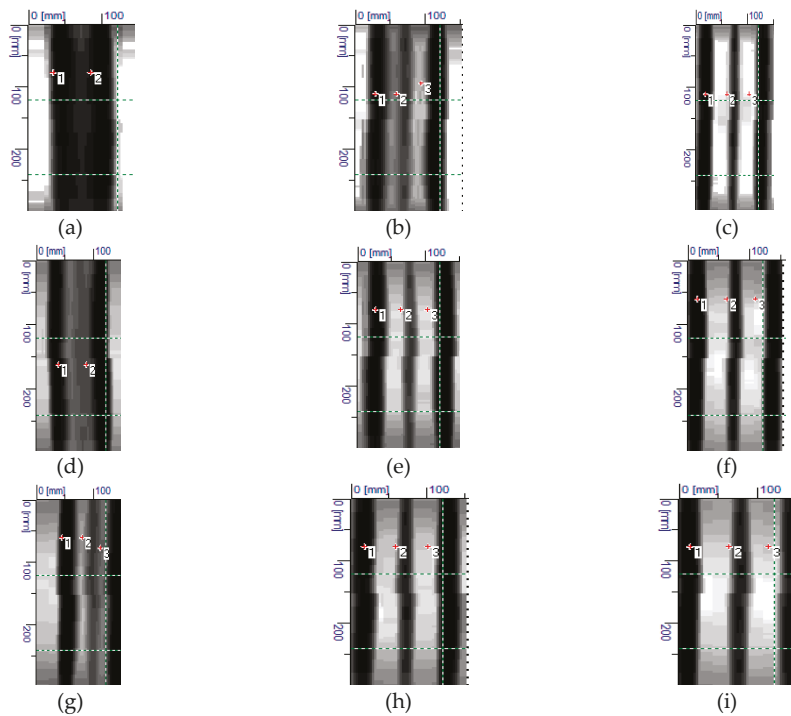
**Figure 18.** Results from tests conducted with the electromagnetic device (1): (a) S-10-20 (result: two rebars,  $\phi_{\text{obs}} = 8 \text{ mm}$ ,  $c_{\text{obs}} = 25 \text{ mm}$ ), (b) S-10-30 (three rebars,  $\phi_{\text{obs}} = 8 \text{ mm}$ ,  $c_{\text{obs}} = 20 \text{ mm}$ ), (c) S-10-40 (three rebars,  $\phi_{\text{obs}} = 10 \text{ mm}$ ,  $c_{\text{obs}} = 21 \text{ mm}$ ), (d) S-16-20 (two rebars,  $\phi_{\text{obs}} = 30 \text{ mm}$ ,  $c_{\text{obs}} = 25 \text{ mm}$ ), (e) S-16-30 (three rebars,  $\phi_{\text{obs}} = 16 \text{ mm}$ ,  $c_{\text{obs}} = 18 \text{ mm}$ ), (f) S-16-40 (three rebars,  $\phi_{\text{obs}} = 20 \text{ mm}$ ,  $c_{\text{obs}} = 20 \text{ mm}$ ), (g) S-20-20 (three rebars,  $\phi_{\text{obs}} = 20 \text{ mm}$ ,  $c_{\text{obs}} = 25 \text{ mm}$ ), (h) S-20-30 (three rebars,  $\phi_{\text{obs}} = 20 \text{ mm}$ ,  $c_{\text{obs}} = 18 \text{ mm}$ ), and (i) S-20-40 (three rebars,  $\phi_{\text{obs}} = 20 \text{ mm}$ ,  $c_{\text{obs}} = 22 \text{ mm}$ ).

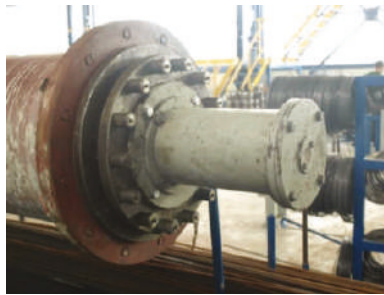
**Figure 1.** Little mould attached to steel mould used for manufacturing spun concrete power poles.

A sample of the concrete mixture used for the manufacture of spun concrete power poles was prepared for these investigations. The sample was made in a little mould with an inside diameter of 150 mm and a height of 300 mm (Figure 1), attached to the steel mould used for manufacturing spun

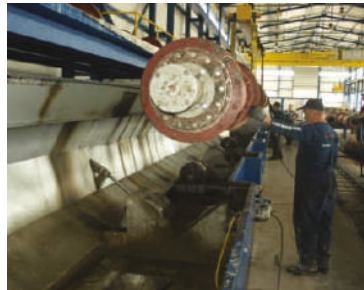
**Figure 2.** Steel mould with attached little mould is being placed in centrifuge.

concrete power poles in one of the precast concrete plant in Poland [15]. The steel mould together with the attached little mould was placed in a centrifuge (Figure 2) and subjected to spinning for 8 min at the maximum speed of 600 rpm. After concrete mixture spinning, the excess of evaporable water was removed from the little mould and the latter, together with the moulded sample, was transferred to a steam box. After about 4 h, concrete spinning steam was fed gradually (the temperature rising at a rate not higher than 10 °C/h) into the steam box. The temperature in the steam box did not exceed 60–70 °C and the concrete was cured for 8 h. Then, the supply of steam to the steam box was turned off to allow the moulds to naturally cool down to a temperature below 40 °C. Subsequently, the sample was extracted from the mould and was left in laboratory conditions for two weeks. An about 10 mm thick slice (Figure 3), in which the characteristic structure of spun concrete is visible, was cut out from the sample to be used in the tests.

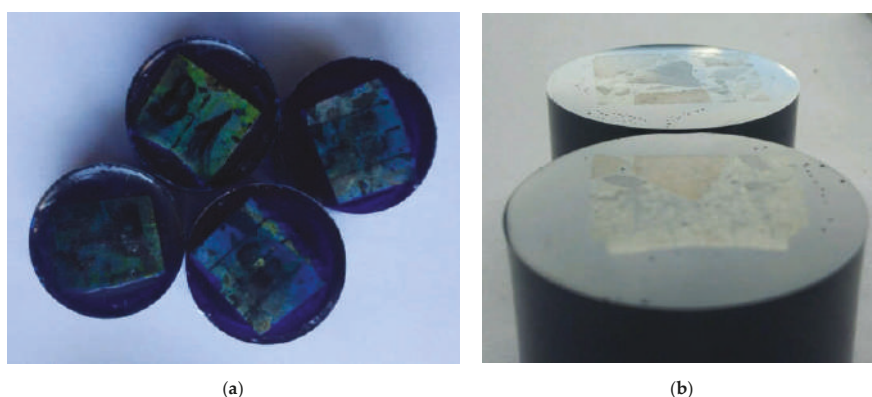
**Figure 18.** Samples for testing in nanoindenter: (a) samples embedded in epoxy resin; and (b) samples with surface polished for testing.

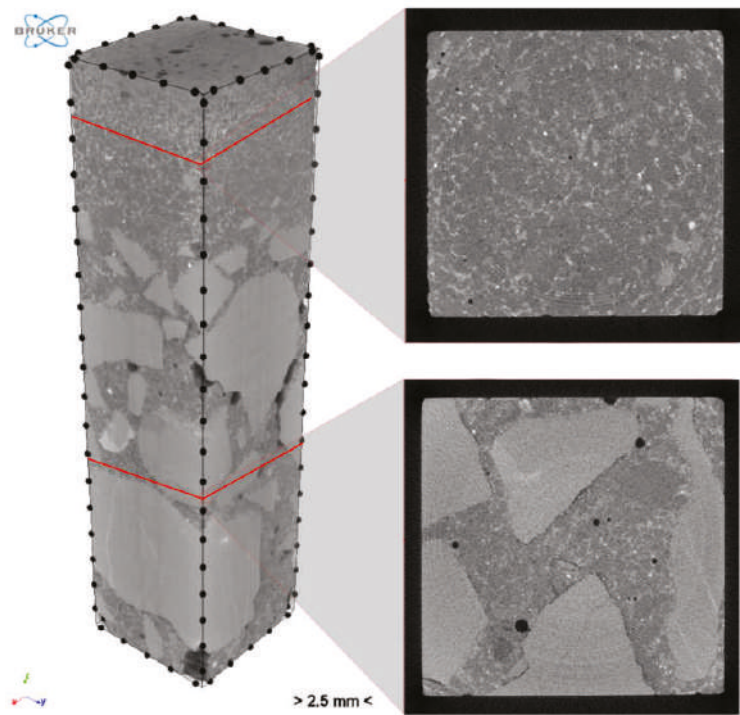
Figure 29. Reconstructed structure of sample with exemplary cross sections.

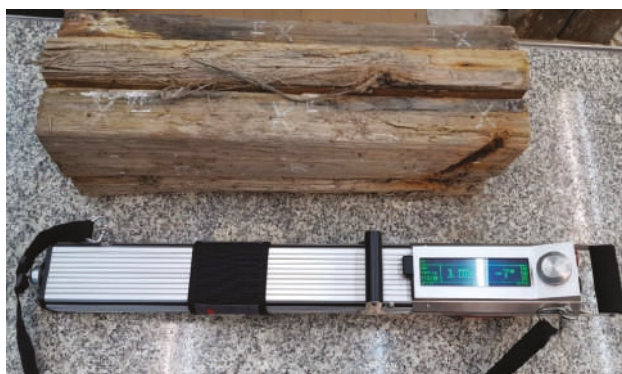
**Figure 3.** IML RESI PD-400S device used in tests.

The test consists of measuring the energy needed to drill the resistance drilling device's metal needle into the material. The test makes it possible to detect structural discontinuities, damage, knots and other flaws and also to estimate the density and strength of the material [22]. The device measures the drilling resistance of a drill with a diameter of 1.5–3.0 mm and a length of 300–500 mm, rotating at a constant speed of about 1500 rpm (Figure 3).

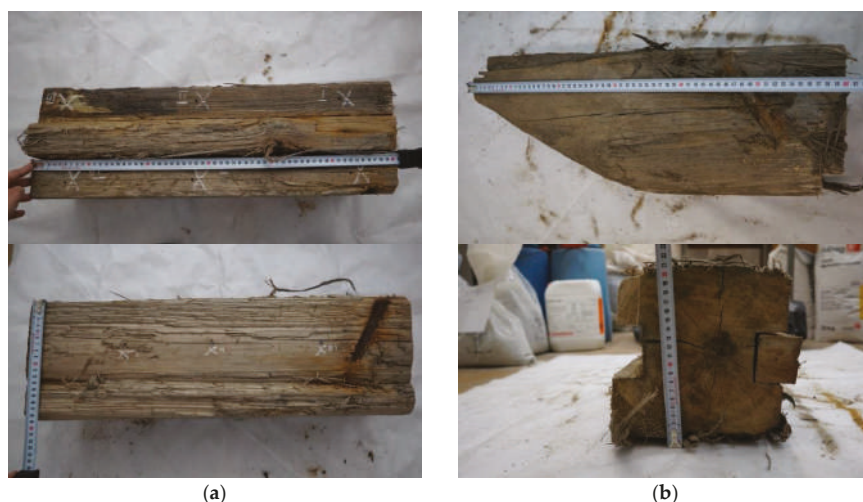
**Figure 5.** Samples and their dimensions: (a) sample 1 cross section 18 cm × 20 cm and length 60 cm, (b) sample 3 cross-section 18 cm × 20 cm and length 60 cm with cut.

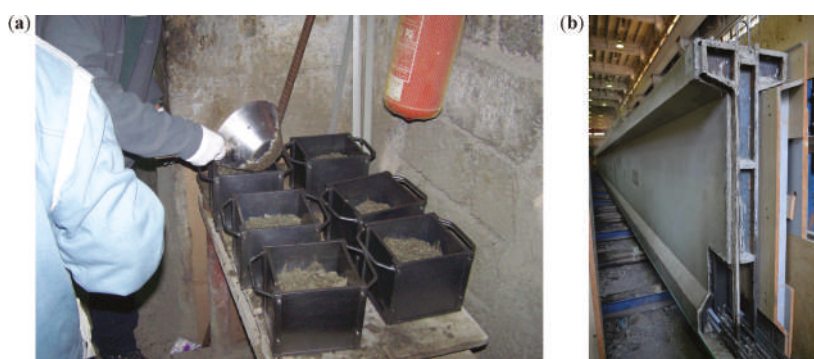
**Figure 4.** (a) making of the specimens; (b) manufacture of the V03 girders.

The testing was conducted similarly to the first stage of the experiment with the sole difference that besides the Original Schmidt N and SilverSchmidt N, the SilverSchmidt L both with and without the mushroom attachment was used. The SilverSchmidt L with the attachment is primarily used to test very young concrete, which is why it was used only during the first 2 days (i.e., first three measurement times), but not beyond. Figure 4 shows the manufacturing and testing of the cube specimens.

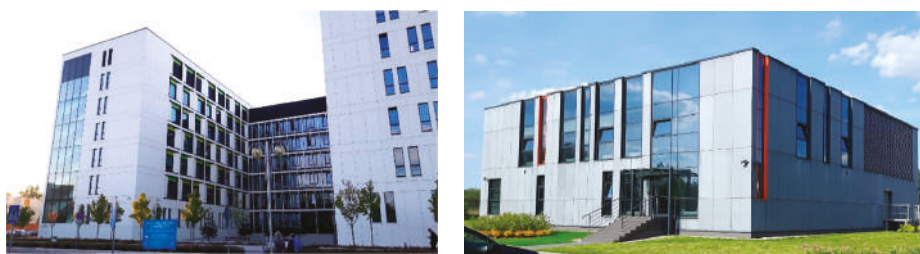
**Figure 1.** Exemplary uses of fibre-cement boards as ventilated façade cladding.

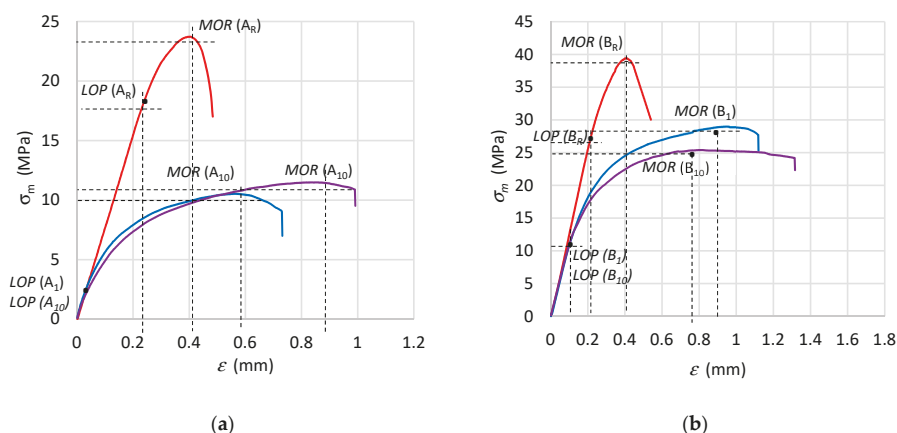
**Figure 4.** Bending  $\sigma$ – $\varepsilon$  relation for specimens of fibre-cement boards: (a) series A, (b) series B. LOP: limit of proportionality; MOR: modulus of rupture.

Figure 4 shows  $\sigma$ – $\varepsilon$  graphs under bending for the specimens of all the tested fibre-cement boards.

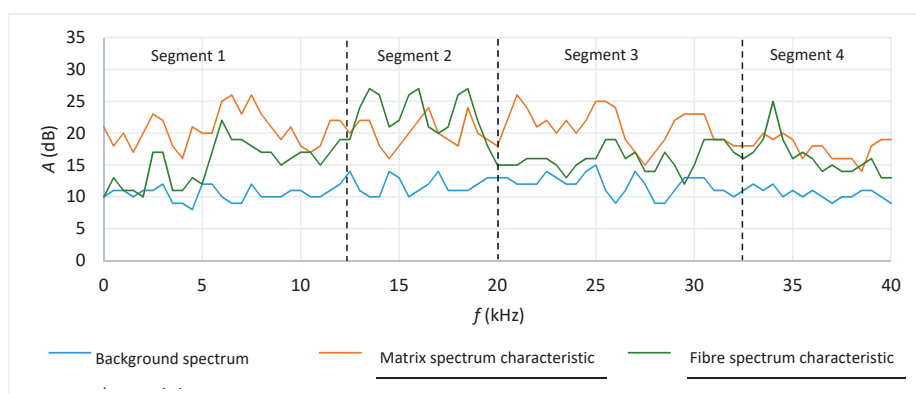
**Figure 7.** Background, fibre and cement matrix acoustic spectrum characteristics as function of frequency [12].

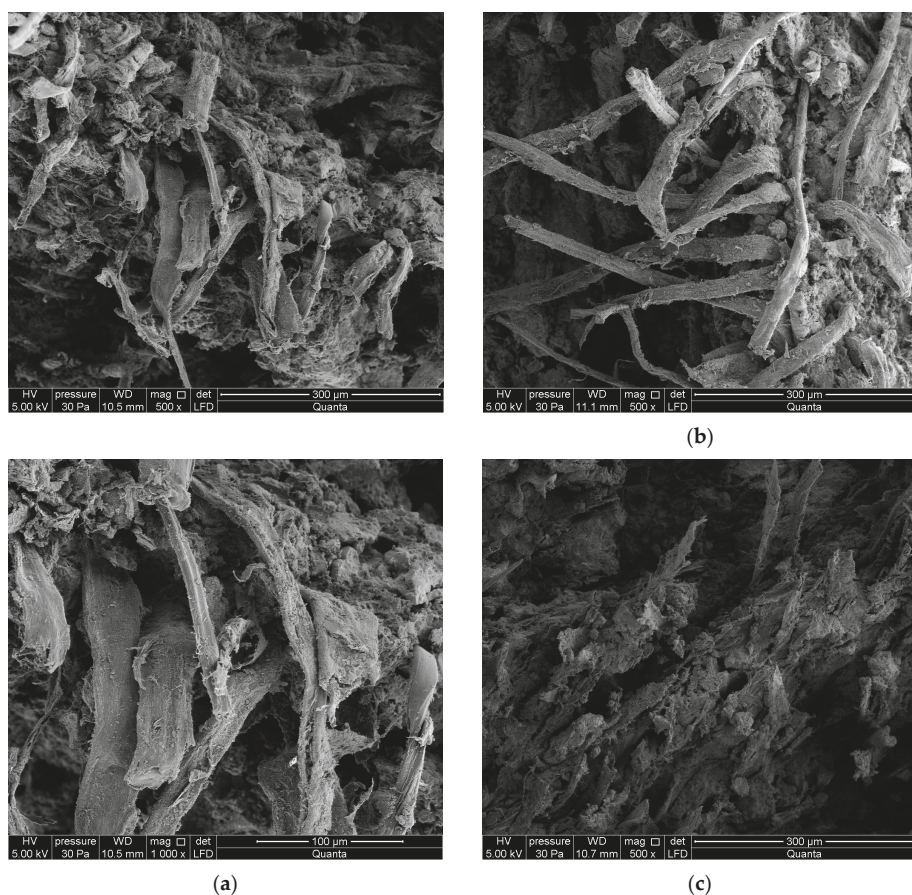
**Figure 13.** SEM images of boards: (a) series B<sub>R</sub> (magnification 1000× at top, 500× at bottom), (b) series B<sub>1</sub>, (c) series B<sub>10</sub>.

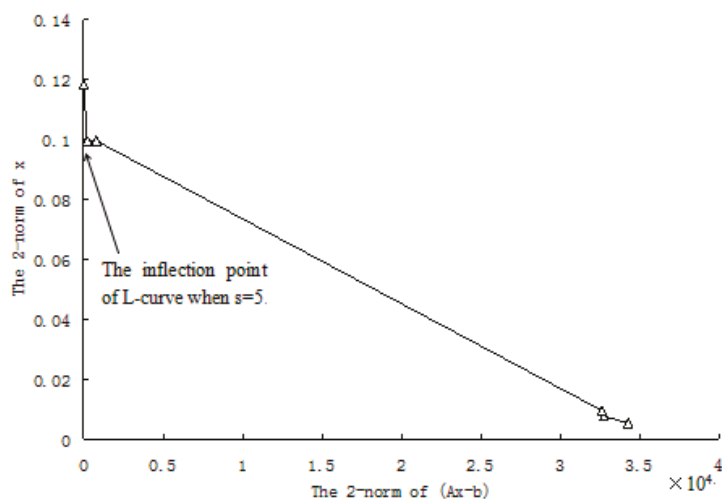
**Figure 2.** The L-curve used to determine the number of remained singular values in singular value truncation (SVT) for case 1.

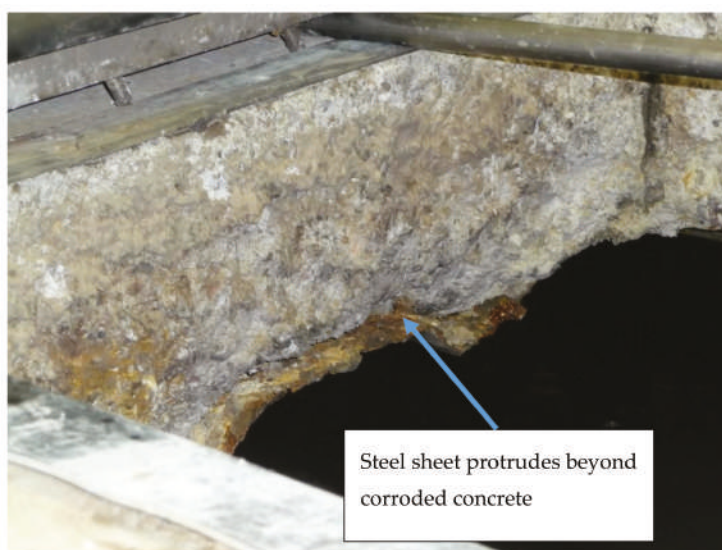
**Figure 2.** The folded sheet corroded more slowly than the concrete. Approximately 20 mm of sheet protrudes beyond the concrete. When built, concrete and steel were on one plane.

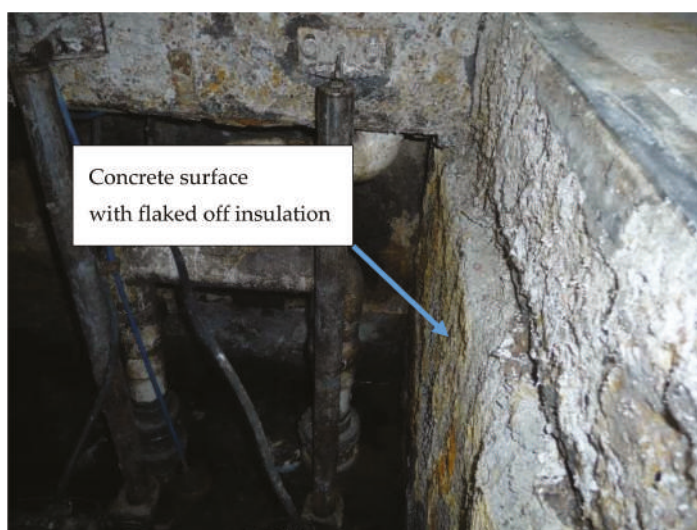
**Figure 3.** Walls below the ceiling slab were originally covered with insulation but in a considerable area of the walls this insulation had already flaked off.

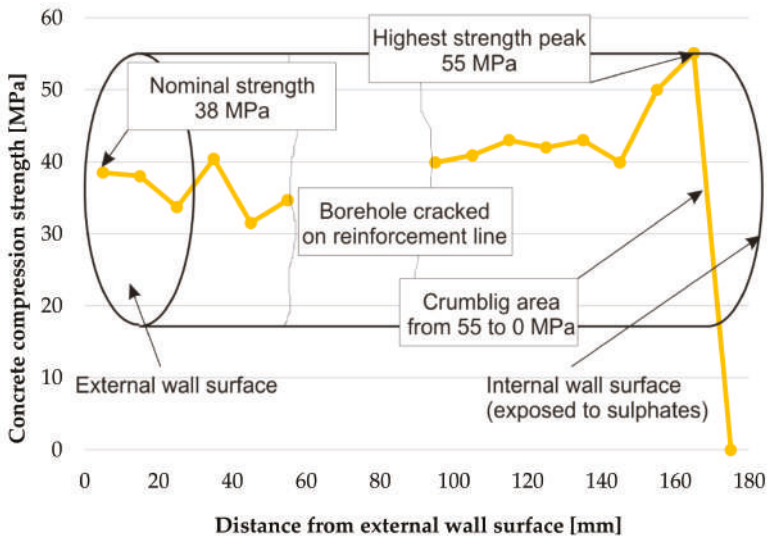
Figure 10. Change of concrete strength across the tank wall tested on borehole No. 3.

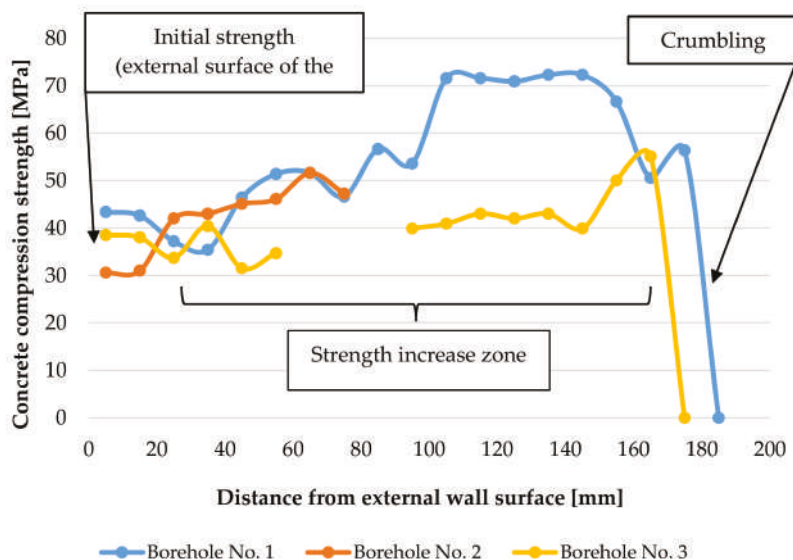
Figure 11. Change of concrete strength across the tank wall thickness in three boreholes.

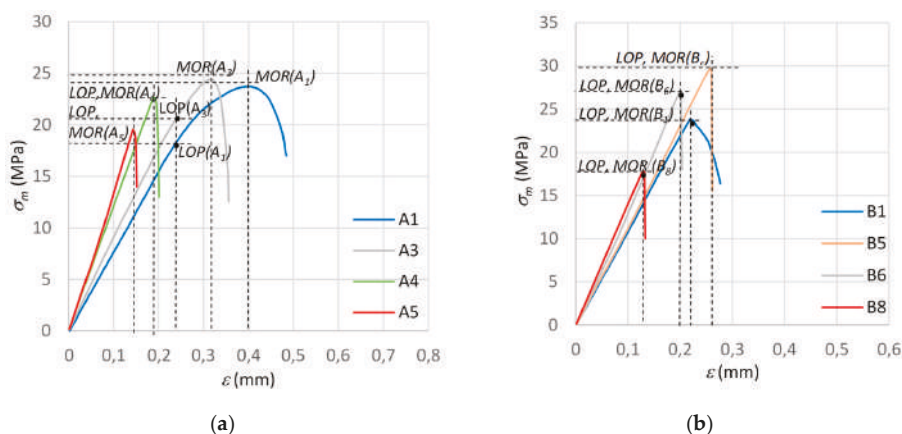
**Figure 5.**  $\sigma-\varepsilon$  dependence under bending for fibre-cement boards: (a) series A, (b) series B. LOP, limit of proportionality.

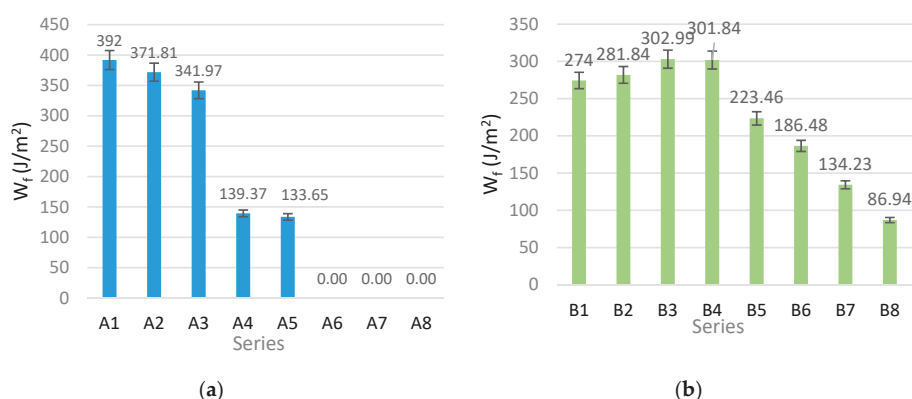
**Figure 6.** The values of notch toughness  $W_f$  for air-dry samples (case 1) and samples exposed to the temperature of 400 °C (cases 2–8): (a) series A, (b) series B.

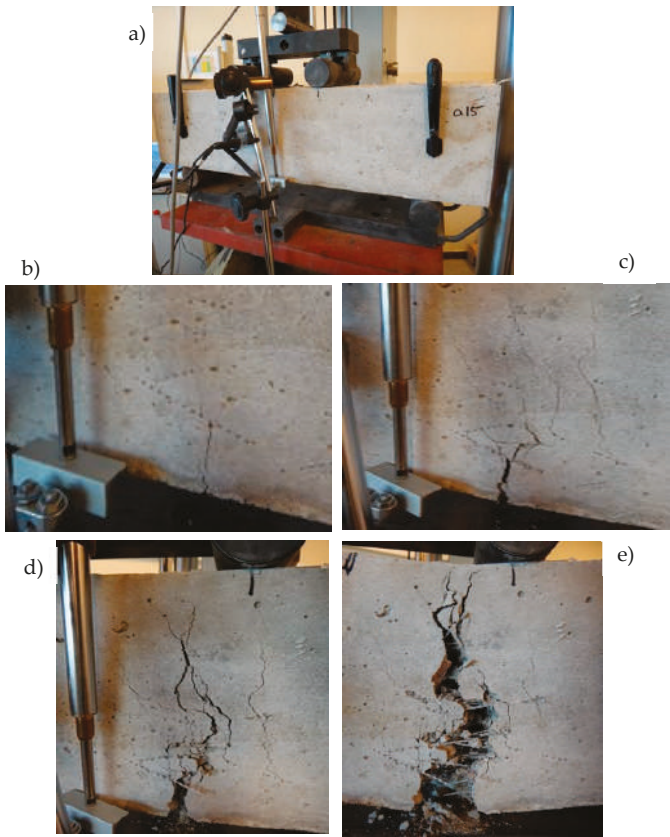
**Figure 3.** Four-point bending test: (a) sample before the test, (b) first crack at  $f_{cr}$  point, (c) multicracking (micro- and macrocracks), (d) destruction - propagation process, (e) view after the test.

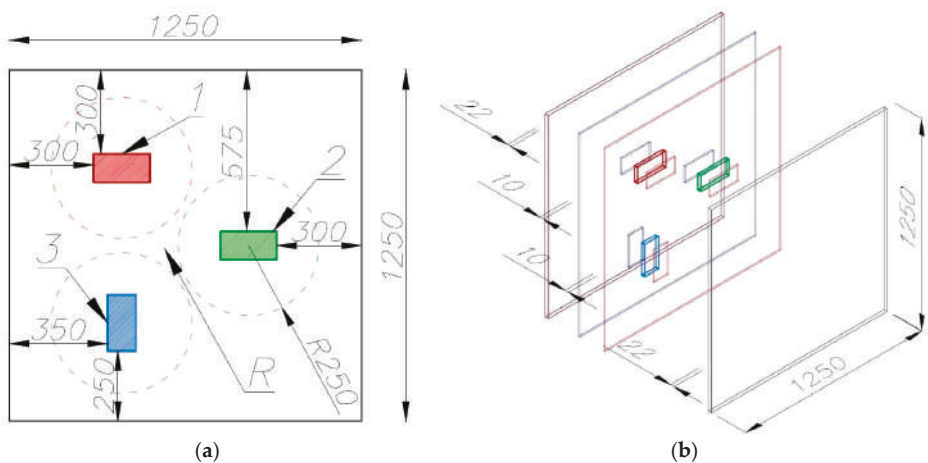
**Figure 1.** Geometrical structure of the partition model (given units in mm): (a) arrangement of material inclusions, internal structure. (b) View of the 3D partition model where inner boards with holes and inclusions are marked blue and red, while the outer boards are marked violet and grey. Designations in figures: 1—XPS inclusion, 2—granite inclusion, 3—steel inclusion, and R—homogenous area without inclusion.

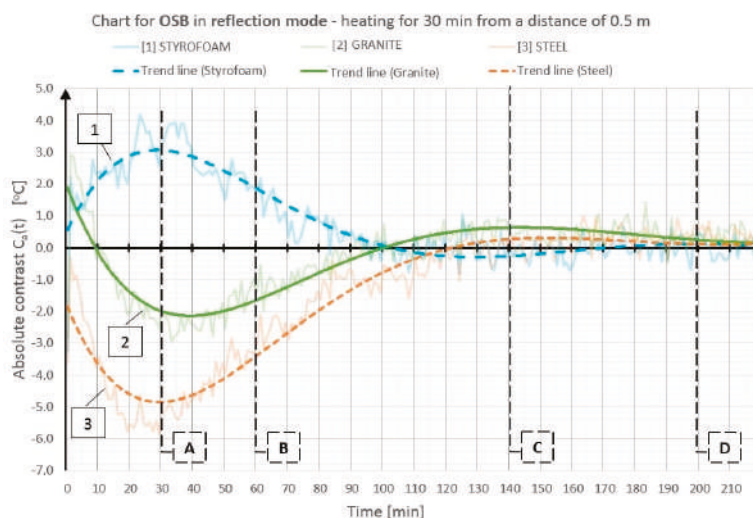
**Figure 4.** Diagram of the absolute contrast for measurement in a reflection mode for the OSB partition model with heating from a distance of 0.5 m (based on thermograms in Figure 3, row I).

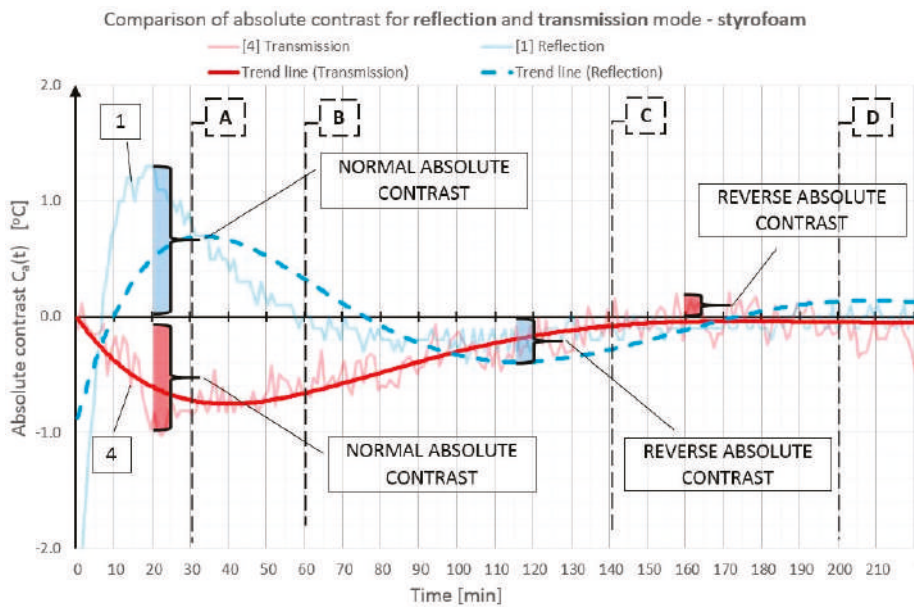
**Figure 13.** Diagram of absolute contrast in a reflection mode and in a transmission mode for Styrofoam inclusion, with marked places where normal absolute contrast and inverse absolute contrast occur (heating from a distance of 1.5 m).

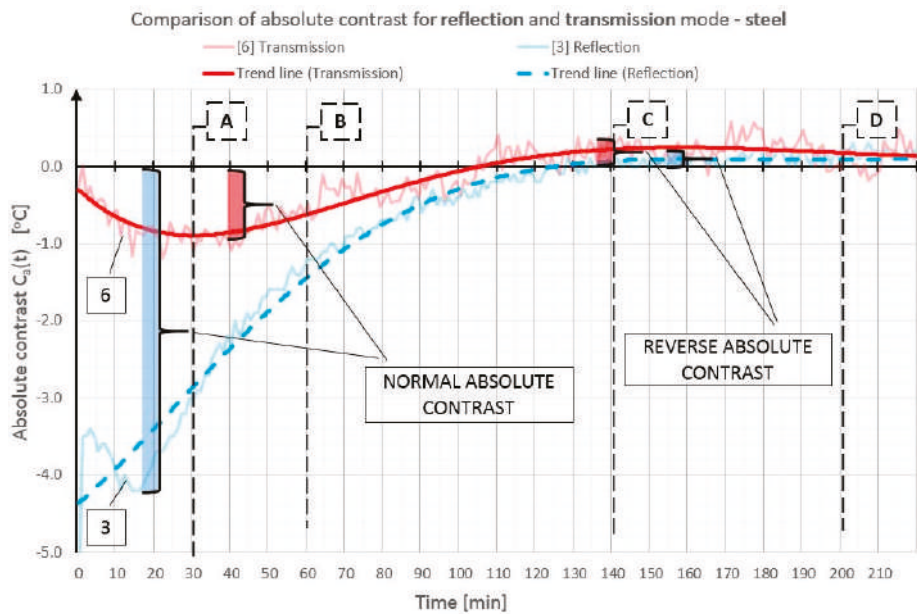
**Figure 15.** Diagram of absolute contrast in a reflection mode and in a transmission mode for steel inclusion, with marked places where normal absolute contrast and inverse absolute contrast occur (heating from a distance of 1.5 m).

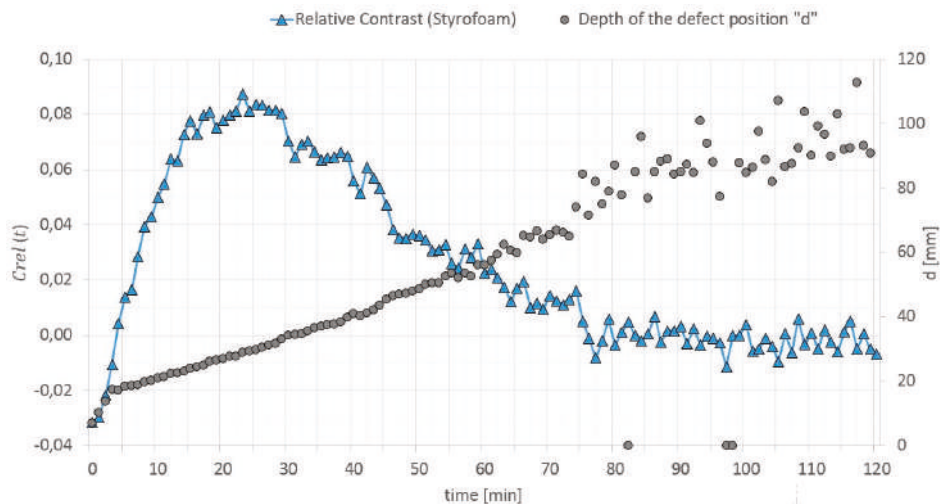
Figure 18. Relative contrast and defect location depth versus time (Styrofoam).

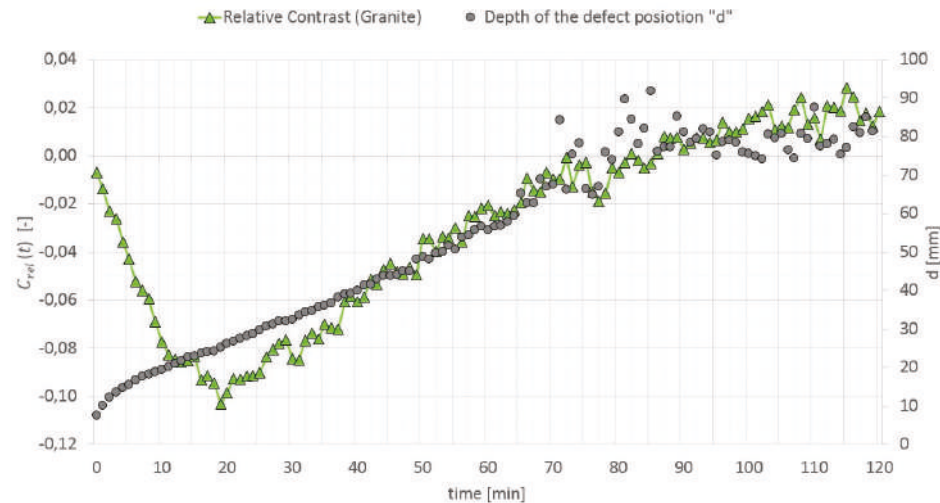
Figure 19. Relative contrast and defect location depth versus time (Granite).

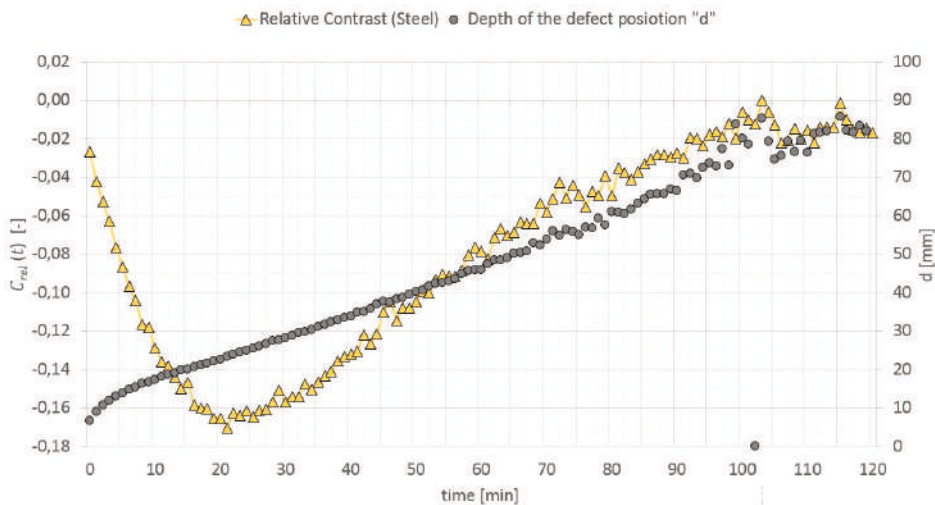
Figure 20. Relative contrast and defect location depth versus time (Steel).

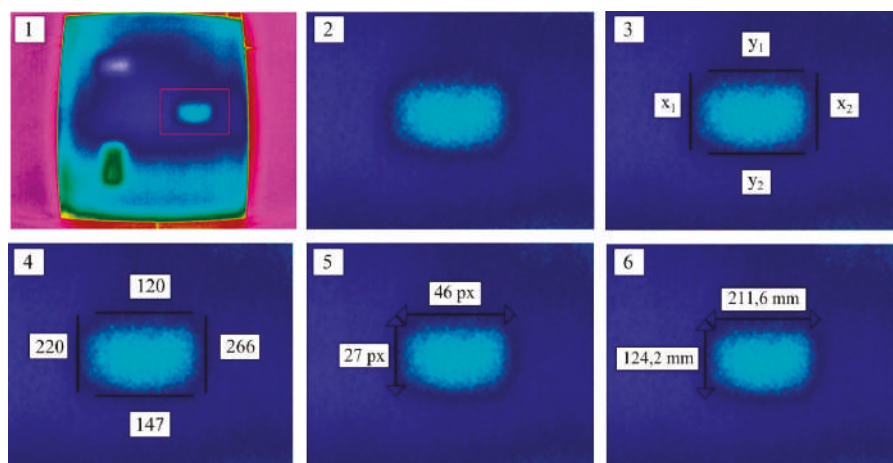
**Figure 21.** Procedure for estimating the defect size on the basis of the known size of a single pixel (4.6 mm).

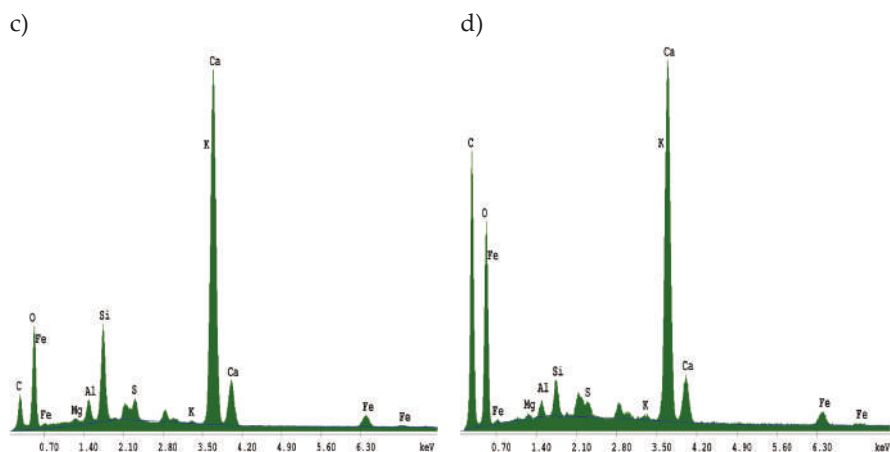
**Figure 6.** Results obtained using the energy dispersive X-ray spectroscopy (EDS) analyzer for board C: (a) areas of elemental composition analysis, (b) results of EDS in point 1, (c) results of EDS in point 2, (d) results of EDS in point 3.

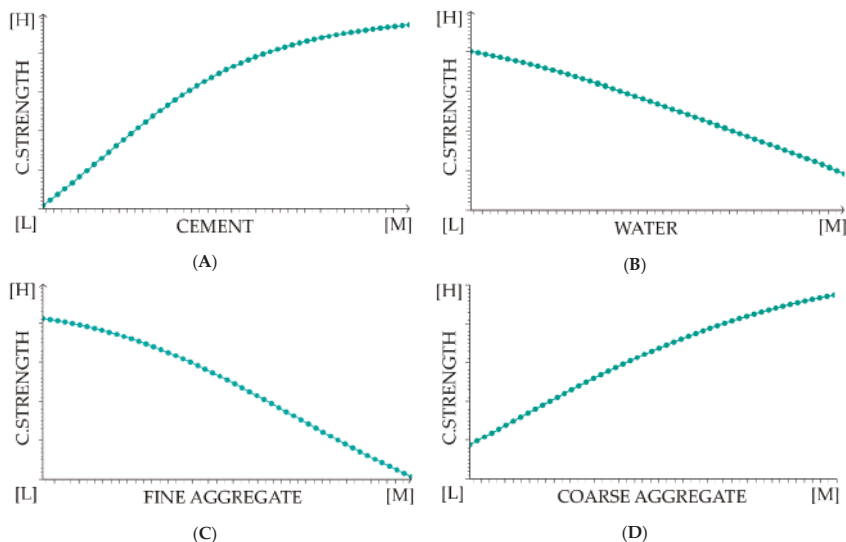
**Figure 7.** Output charts. The diagrams show variations in output variables for a single input variable, while the others are fixed. The vertical axis is the full compressive strength of concrete. The horizontal axis is the amount of material. (A) Cement; (B) water; (C) fine aggregate (sand 0–2 mm); (D) coarse aggregate (aggregate above 2 mm); [H], [M]—Higher/More; [L]—Lower/Less.

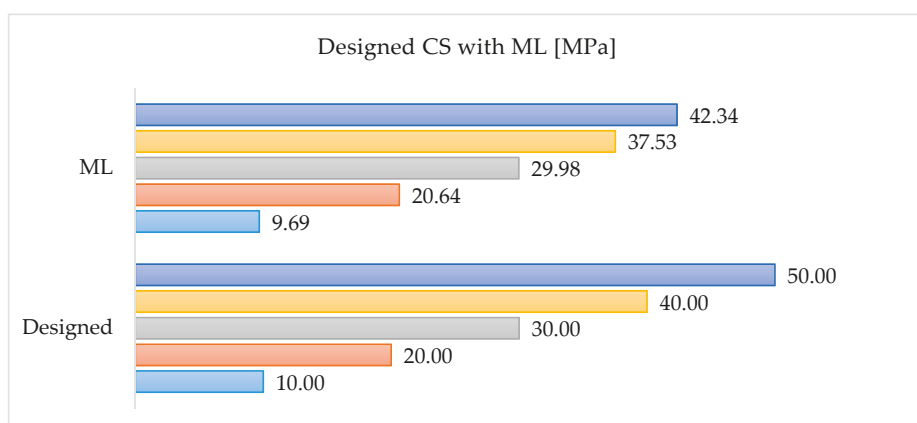
**Figure 9.** Comparison between designed Compressive Strength (CS) and calculated from Machine Learning (ML) formula.

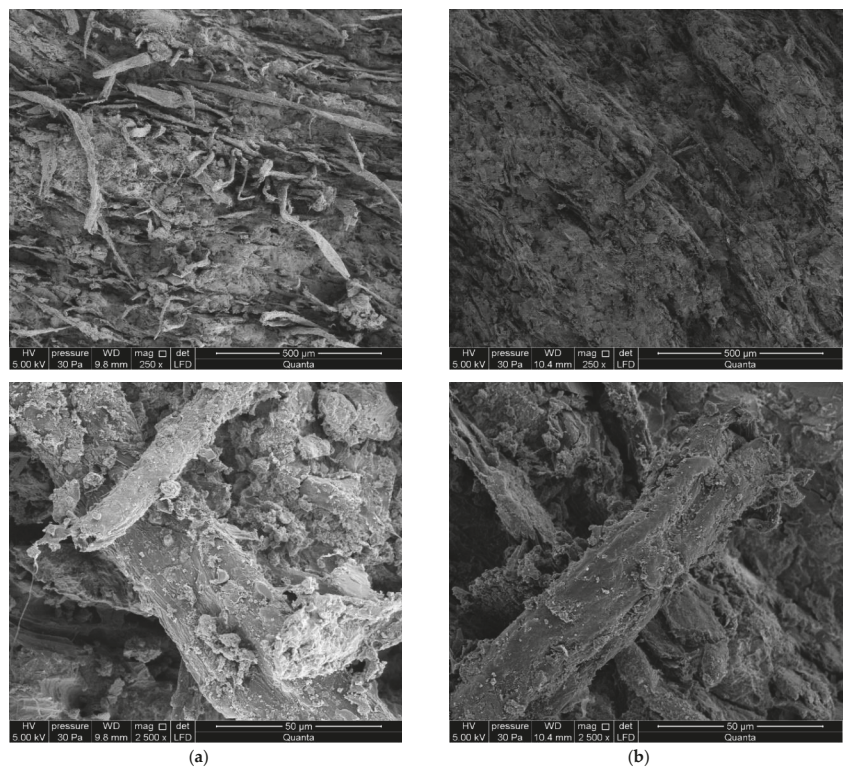
**Figure 6.** The microscopic observations of the applied fibres, in scanning electron microscope (SEM) with scale bar in sequence 1 mm, 500 µm and 50 µm: (a) air-dry condition (reference board), (b) board exposure to temperature of 230 °C-3 h.

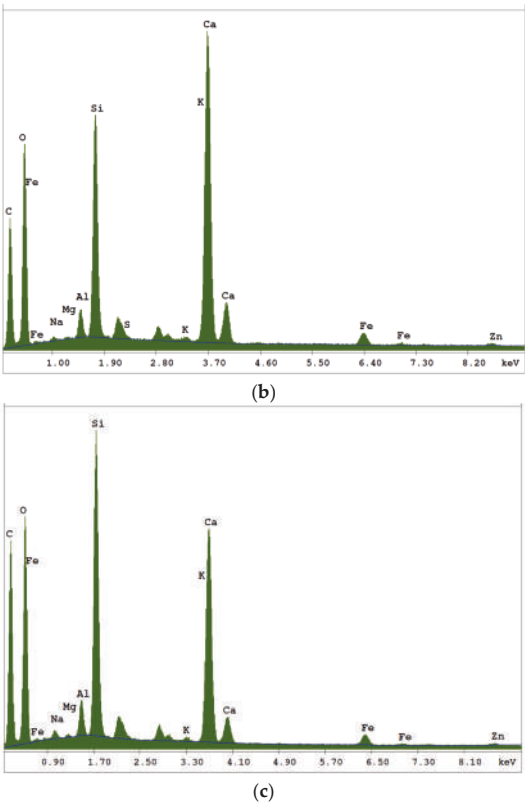
**Figure 7.** Composition analysis (EDS) of tested boards: (a) matrix, (b) fibre of air-dry condition (reference board) and (c) “fibre” of board exposure to temperature of 230 °C-3 h.

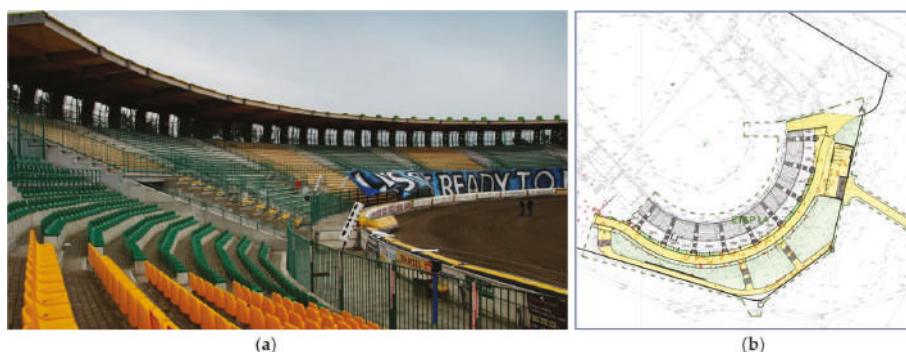
**Figure 2.** Swiss Krono Arena: (a) the view on the grandstand, (b) the location of the grandstand on the land development plan.

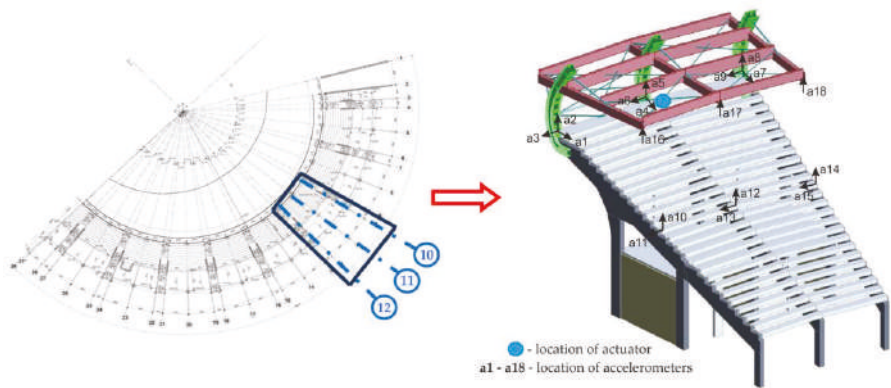
Figure 4. The stand section selected for field tests.

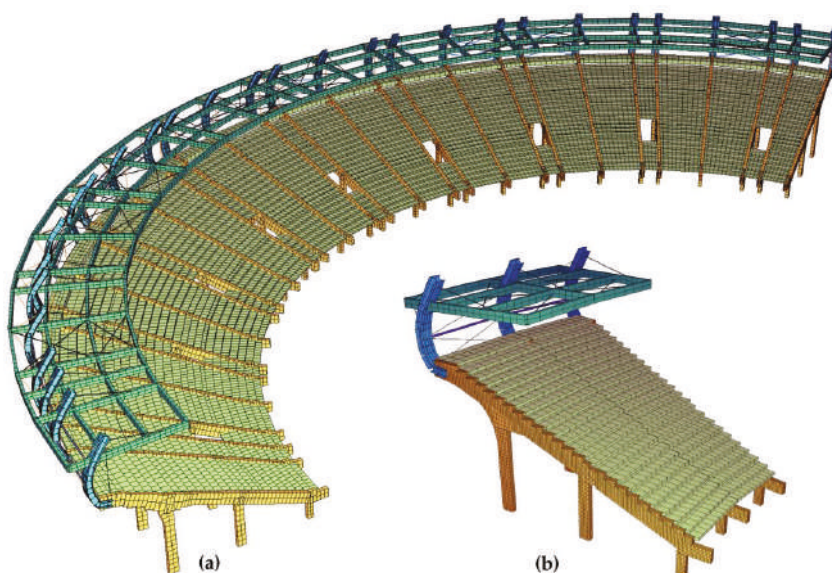
**Figure 17.** (a) Numerical model of the stadium, (b) numerical model of a single section of the stand.

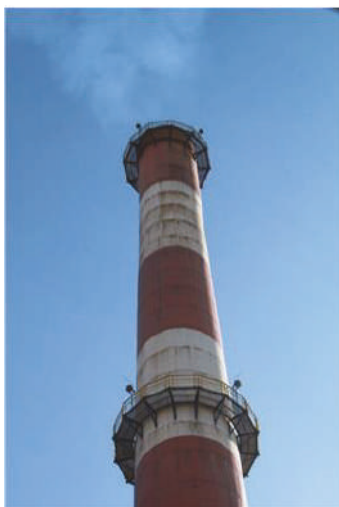
**Figure 1.** Deposition of condensation on outer surface chimney wall along construction joints.

As the condensate penetrates through cracks in the lining, it makes the mineral wool damp, whereby the latter loses its insulating properties. Moreover, the damp mineral wool sinks, and as a result, areas devoid of thermal insulation are created. As the coefficient of thermal conductivity decreases, the temperature of the chimney's inner wall falls further, and so does the temperature of the flue gas. As a result, more and more flue gas condenses on the chimney's inner wall, whereby the degradation processes in the chimney's RC shell intensify (Figures 1–3).

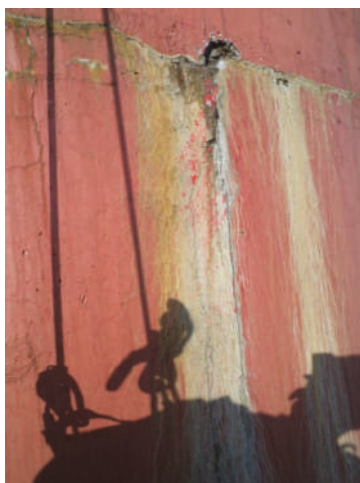
**Figure 2.** Condensation degrading of chimney wall.

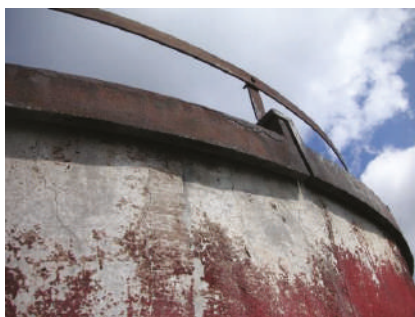
**Figure 3.** Condensation dripping down from a chimney upper ring.

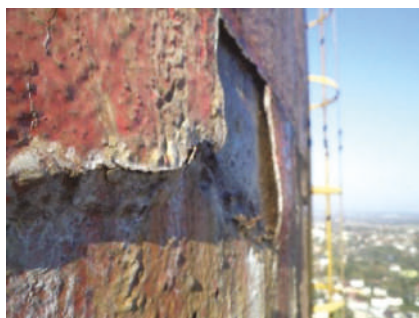
**Figure 4.** Condensation penetrating chimney crown wall.

As condensation drips down the inner wall, it penetrates via cracks to the mineral wool and outside to the reinforcement of the concrete wall, causing intense corrosion of the concrete and the reinforcing steel (Figure 4).

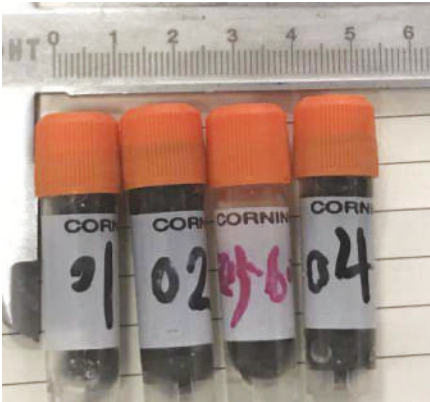
**Figure 1.** Paste and mortar samples encased in epoxy resin after mercury intrusion.

Immediately after the MIP tests finished, the samples were carefully and rapidly removed into small plastic tubes. A quick-hardening epoxy resin was rapidly poured into the tubes to completely cover the samples, and those tubes were quickly and tightly lidded (Figure 1). Those steps were to cease the leakages of mercury from the mercury-filled samples for diminishing the possible dangers to the technicians when handling those CBM samples.

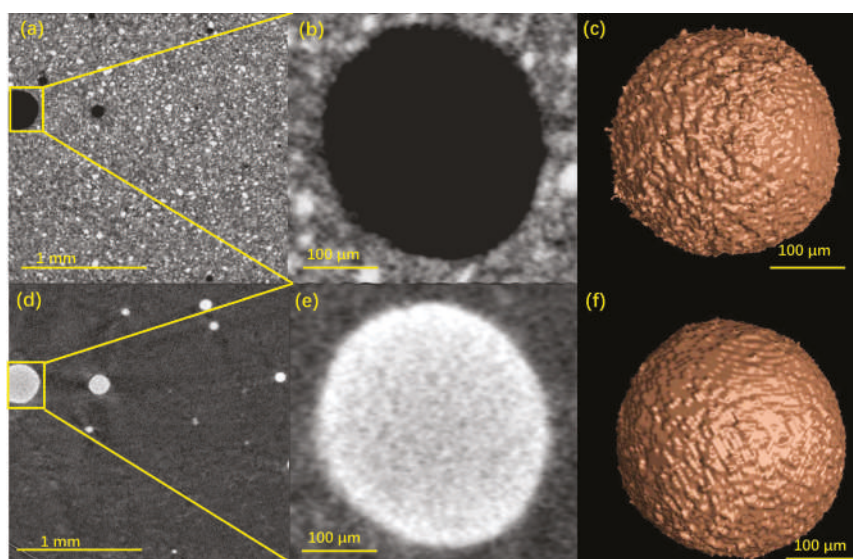
**Figure 8.** Representative images of a VOI in the cement sample (a–c) before and (d–f) after mercury intrusion: (a,d) the 2D sectional view with (b,e) the magnified pore and (c,f) its 3D structure.

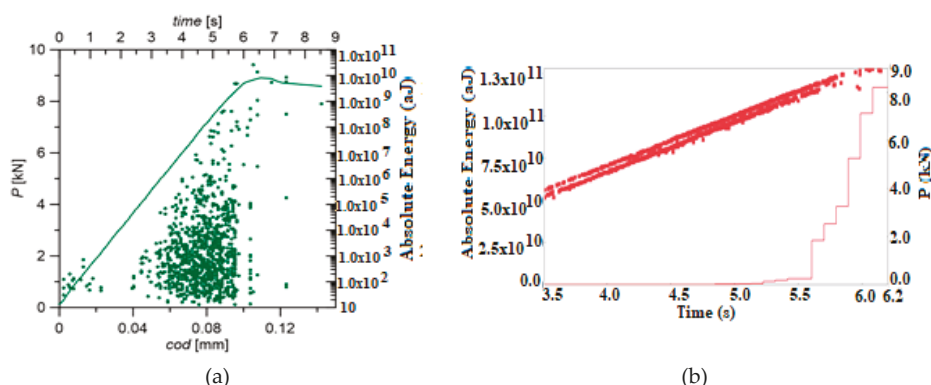
**Figure 3.** The graph of specimen loading (a) with absolute energy of AE signals (aJ) and (b) graph cumulative absolute energy vs. load on time from 3.5 to 6.2 s. The graphs show AE parameters without using the clustering method (identification) of destructive processes.

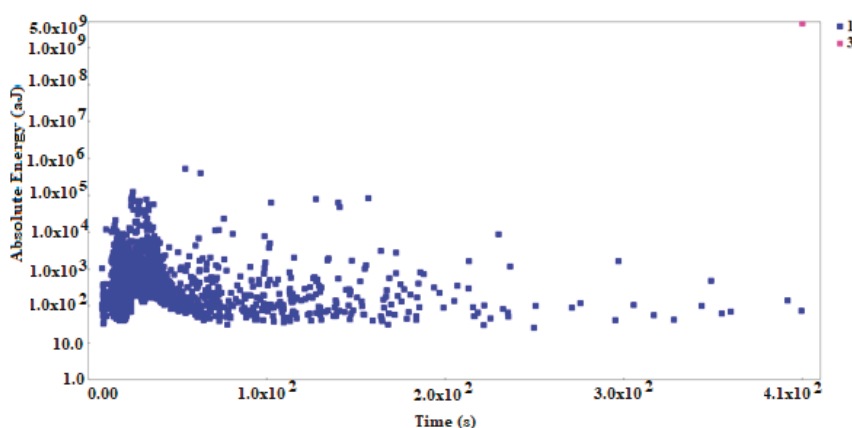
**Figure 6.** Scatterplot: Absolute energy (aJ) vs. time (s) for uniaxial tested specimen.

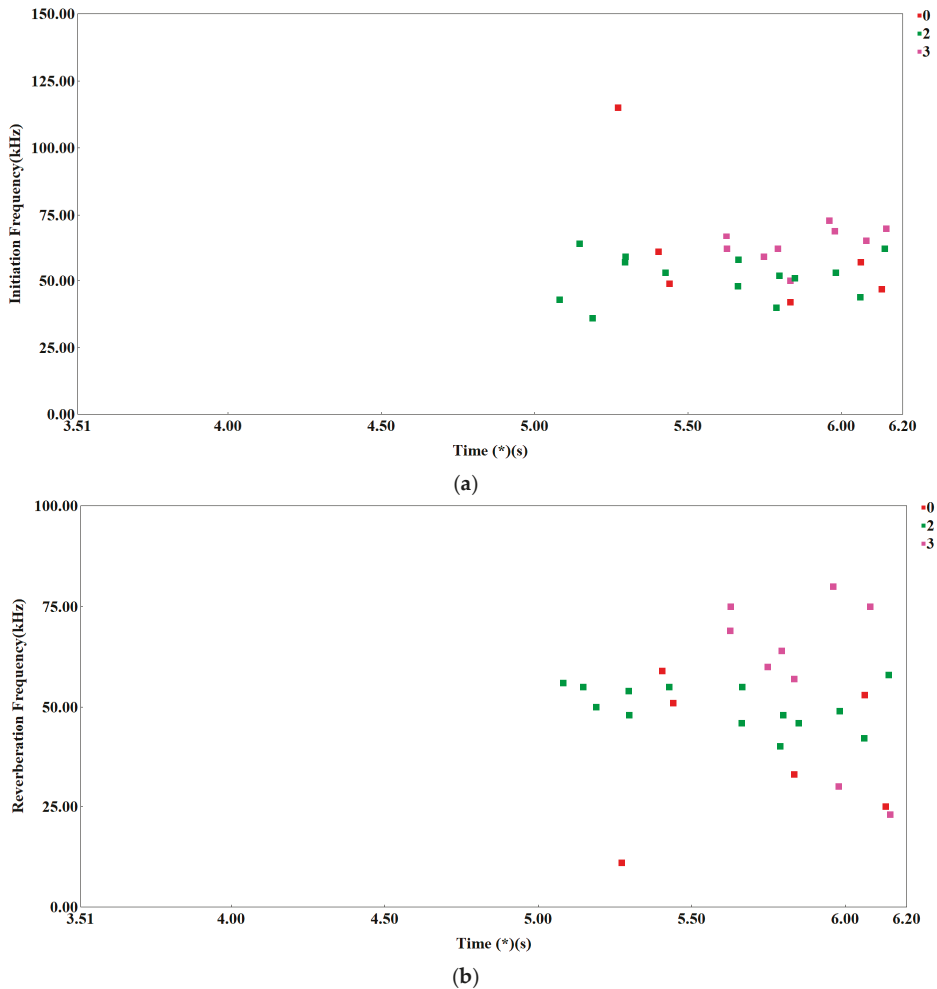
**Figure 7.** Scatterplot: (a) Initiation frequency (IF) (kHz) vs. time (s); and (b) reverberation frequency (RF) (kHz) vs. time (s).
