# Non-destructive Testing of Materials in Civil Engineering

Printed Edition of the Special Issue Published in *Materials*

**Krzysztof Schabowicz**

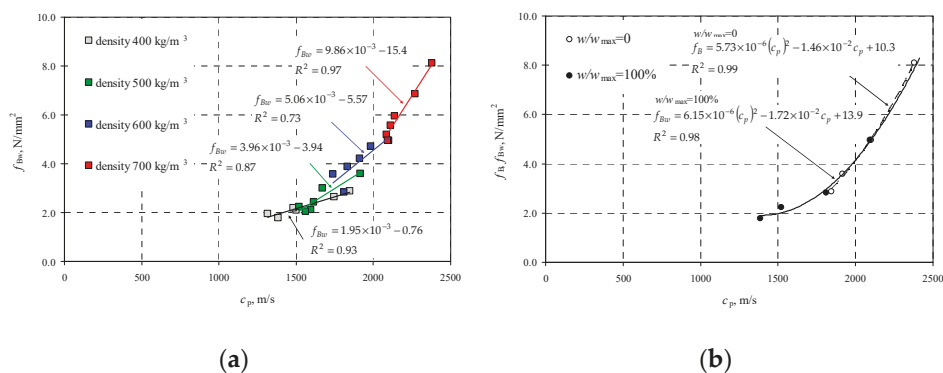
**Figure 8.** Results from P-waves velocity testing: (a) compressive strength of AAC including density classes, and (b) AAC strength in wet concrete ( $f_{Bw}$ ) and totally dry concrete ( $f_B$ ).

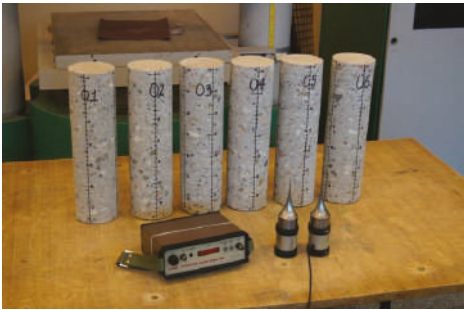
Figure 1. The samples to be tested using ultrasonic device.

The measuring points spaced at every 1 cm (Figures 1 and 2) were marked on the sides of the core samples. Velocity C<sub>L</sub> of ultrasonic wave passage through concrete was measured in two perpendicular directions. No concrete/probe coupling material was used. The probes were set perpendicularly to the tested side surface of the sample (Figure 2). The distributions of velocity C<sub>L</sub> of longitudinal ultrasonic wave passage through the concrete were obtained from the tests (Tables 2 and 3, and Figures 3 and 4).

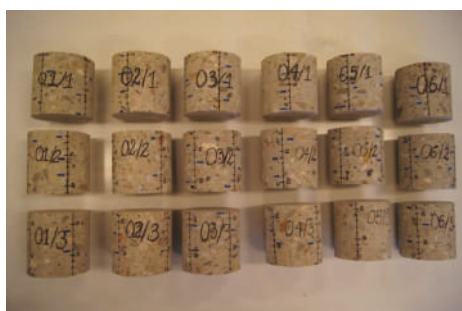
**Figure 7.** Core samples with height/diameter ratio  $h/d = 1$ , obtained from samples 01–06.

For further investigations the core samples (Table 1) were cut into smaller samples (Figure 7) with height  $h = 100$  mm ( $h/d = 1$ ). In the terminal samples (e.g., 01/1—the top of the sample, 01/3—the bottom of the sample) the actual end faces were left unchanged (or were slightly trimmed to make them level). The middle sample (e.g., 01/2) was cut to the required size of 100 mm. Then, the end faces were prepared by grinding for compressive strength tests (Figure 8).

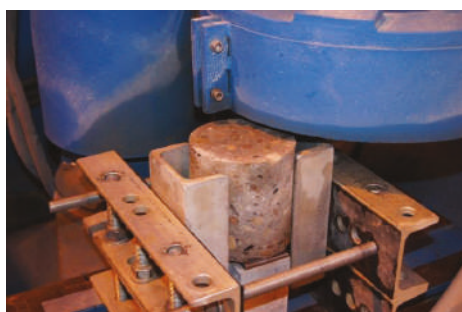
**Figure 8.** One of the core samples during grinding of its end surface.

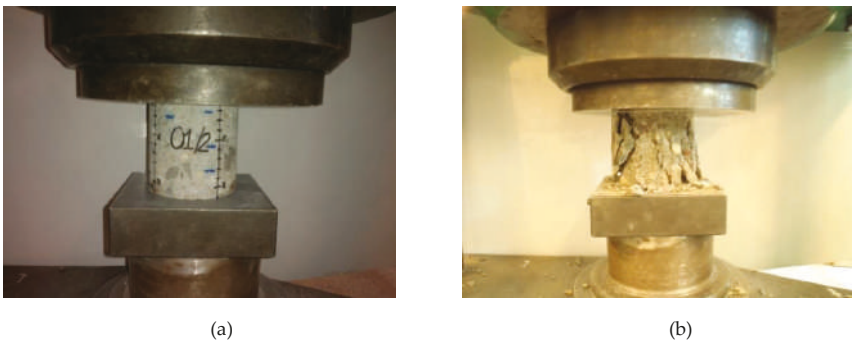
The compressive strength tests were carried out in conformance with standard [13] in the ZD100 strength testing machine (Figure 9a) satisfying the requirements of standard [18]. All the samples showed the same type of failure (Figure 9b). The parameters of the samples and the test results are presented in Table 2.

Figure 9. The sample in strength testing machine: (a) during loading, (b) after failure.

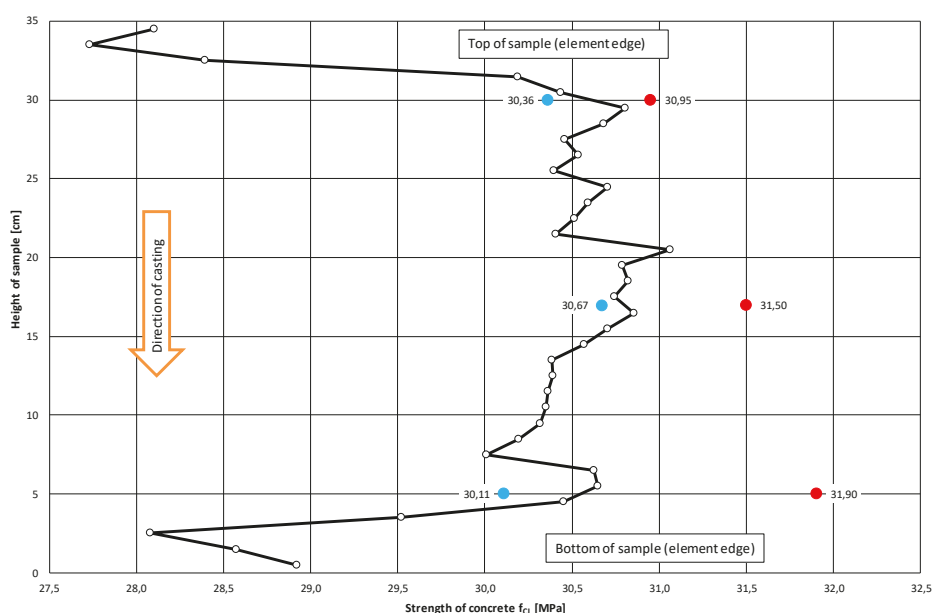
**Figure 10.** The mean distribution of compressive strength  $f_{CL}$  of concrete along the height of the sample taken perpendicularly to top surface of slab. The diagram includes the mean concrete strengths for the top, middle and bottom samples, obtained from ultrasonic tests (marked blue) and destructive tests (marked red).

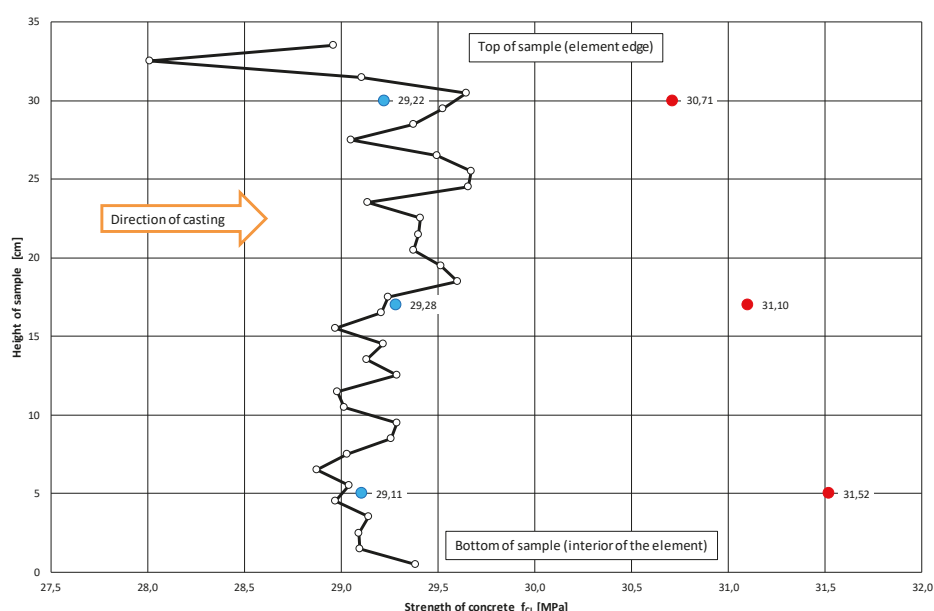
**Figure 11.** The mean distribution of compressive strength  $f_{CL}$  of concrete along the height of the sample taken parallel with the top surface of the slab. The diagram includes the mean concrete strengths for the top, middle and bottom samples obtained from ultrasonic tests (marked blue) and destructive tests (marked red).

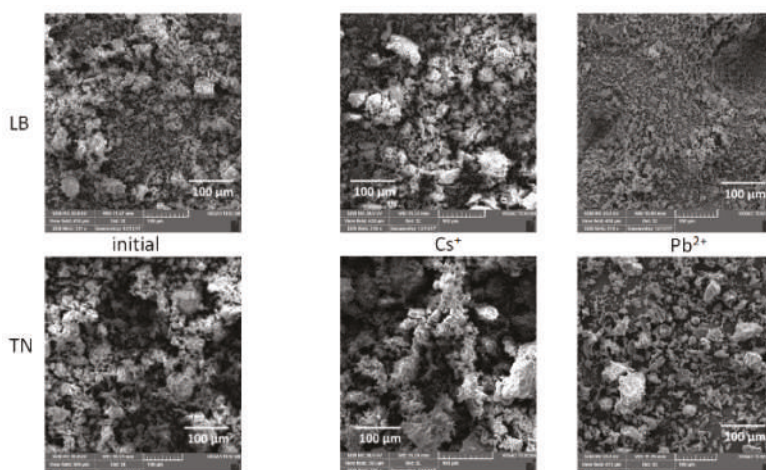
**Figure 2.** SEM images of WBD before and after  $\text{Cs}^+/\text{Pb}^{2+}$  adsorption on LB and TN (magnification of 300 $\times$ ).

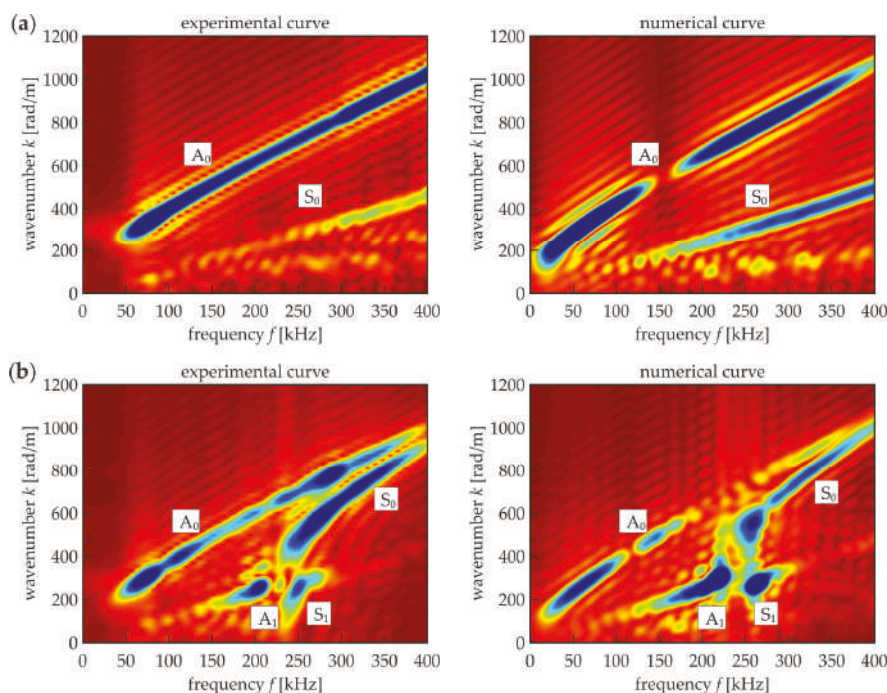
**Figure 6.** Experimental and numerical dispersion curves: (a) steel plate (sample D1)—single layer medium ( $d_s = 3$  mm,  $E_s = 195.2$  GPa,  $\nu_s = 0.3$ ,  $\rho_s = 7741.7$  kg/m<sup>3</sup>); (b) adhesive joint (sample D2)—three-layer medium consisted of two steel plates (parameters same as in (a)) and adhesive film ( $d_a = 0.2$  mm,  $E_a = 5$  GPa,  $\nu_a = 0.35$ ,  $\rho_a = 1330$  kg/m<sup>3</sup>).

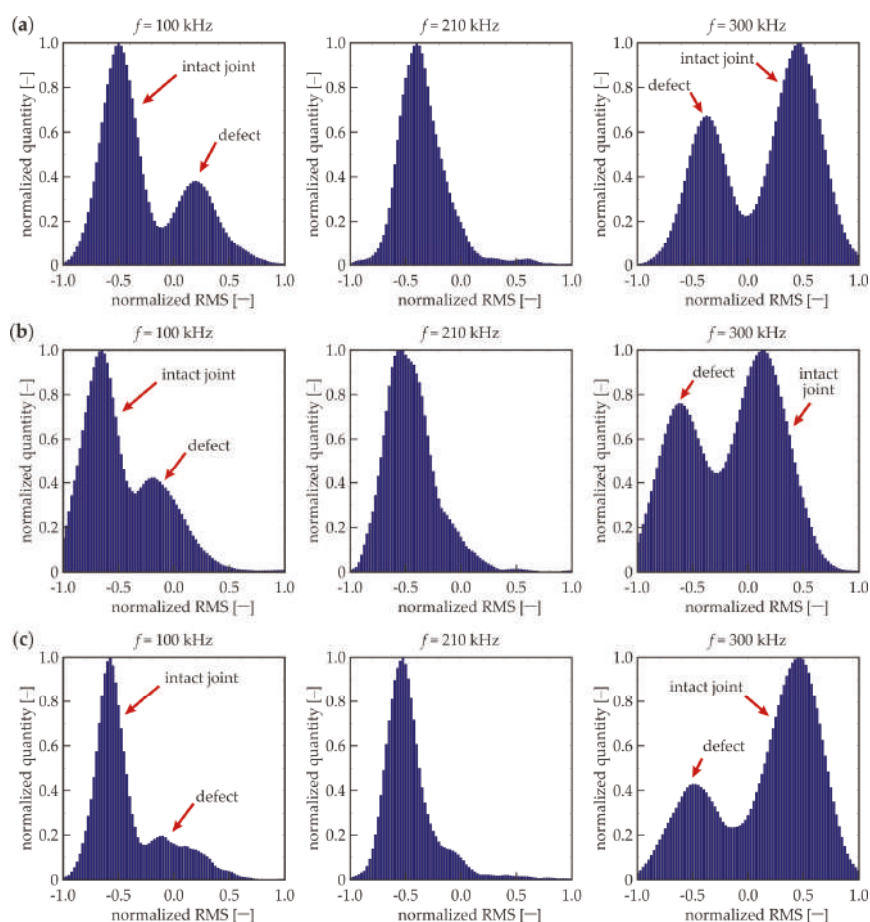
**Figure 13.** Numerical RMS histograms for different excitation frequencies (100, 210, and 300 kHz) and different defects: (a) #2; (b) #3; and (c) #4.
