# Nitrile cup seal robustness in the India Mark II/III hand pump system

Development Engineering

Hans J. Ottosson, Christopher A. Mattson<sup>\*</sup>, Oliver K. Johnson, Thomas A. Naylor

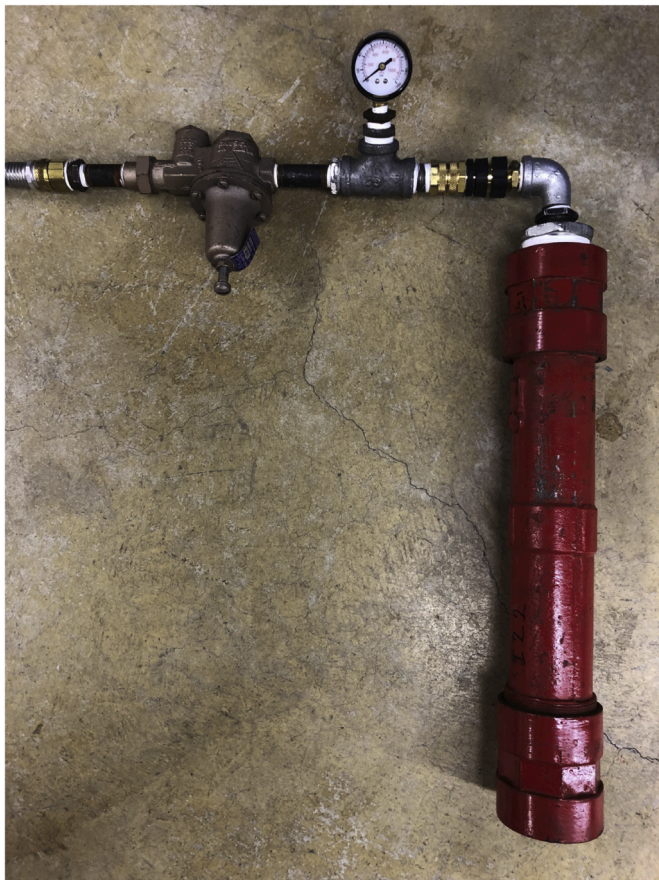
**Fig. 10.** Test setup for determining cup seal leak rate.

To find the leak rate of each purchased seal, a static seal leak-rate test rig was built at Brigham Young University (see Fig. 10). It consisted of a pump cylinder from an India Mark III hand pump system complete with a plunger. Attached to the pump cylinder was a high pressure water source, an adjustable regulator, and a gauge. Different well depths could be simulated by adjusting the pressure of the water entering the pump cylinder. Each seal was tested individually and the data collected and evaluated. The seal being tested was placed in the lower seal position of the plunger (see Fig. 5(c)).

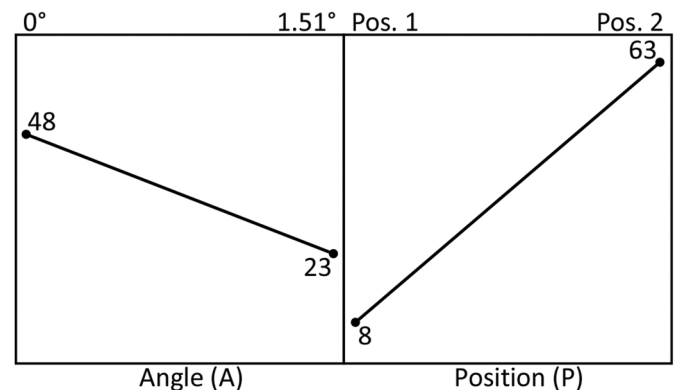
**Fig. 11.** Main effects plot for the design of experiment.

The results from the design of experiments can be seen in Table 7. The change in position had a greater influence on leak rate than the change in angle (see Fig. 11). This can also be seen in Fig. 12 where the second box plot is taller than the other box plots.
